VAN ZANDT COUNTY COURTHOUSE
 121 E. DALLAS ST.
 CANTON, TX 75103

DATE	06/04/2020
PROJECT NO.	1608818045
SHEET NO.	A2.001
1ST FLOOR EXISTING & DEMOLITION

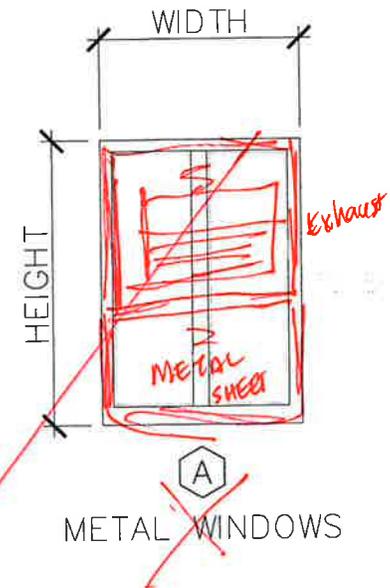
Metal covers the whole outer face of the window/frame.

① CLEAN/REPAINT

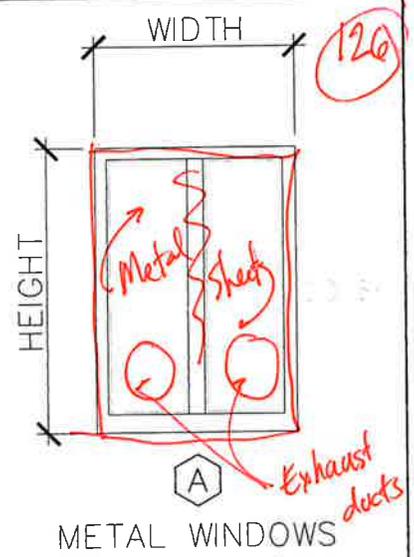
*1 CLEAN/REPAINT
Sheet metal covers the whole window opening allowing two (2) 8-10" Ø metal ducts to pass thru.*

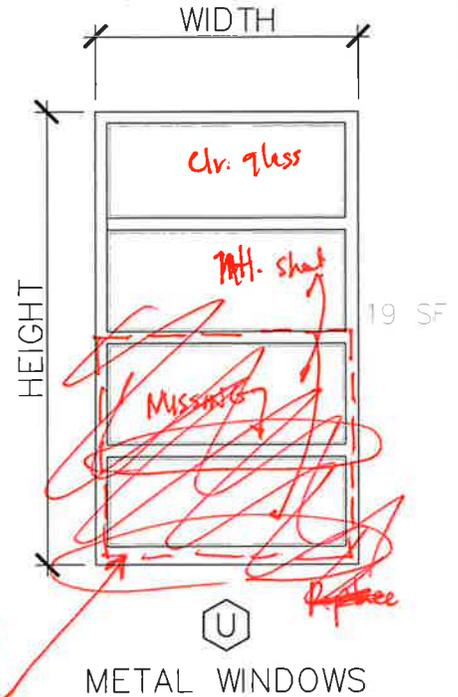
Frame w/ glass fastened to hist. frame on the interior face.

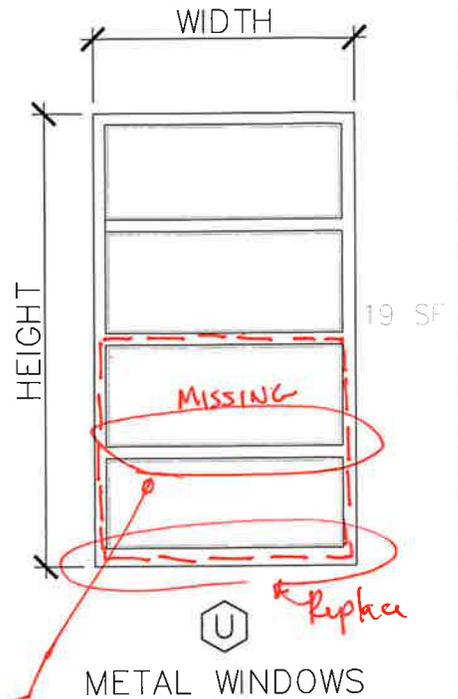
Frame w/ glass fastened to historic frame on the interior face.
