VAN ZANDT COUNTY COURTHOUSE
 121 E. DALLAS ST.
 CANTON, TX 75103

DATE	06/04/2020
PROJECT NO.	1608818045
SHEET NO.	A2.001
1ST FLOOR EXISTING & DEMOLITION

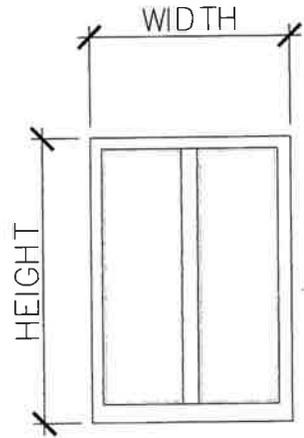
WINDOW			SPECIFIC CONDITION NOTES																			
WINDOW NO. 101	EXPOSURE	TYPE A	EXTERIOR FINISH	INTERIOR FINISH	GLASS	FRAME	SASHES	HARDWARE	GLAZING MATERIAL	WEATHERSTRIPPING	SUPPORT MATERIAL	SILL	PERIMETER SEALANT									
A-101-E		METAL	Good	Good	Good	Good	N/A		BAD	BAD	Good	FAIR	BAD									
SCALE: 1/4" = 1'-0"			WINDOW SURVEY/WINDOW TYPES																			
DATE:		JOB NO.: 2023.113	VAN ZANDT COUNTY COURTHOUSE																			
KOMATSU ARCHITECTURE			121 E. DALLAS STREET CANTON, TEXAS 75103																			
			TYPE A																			
			Sheet ___ of ___

① CLEAN/REPAINT

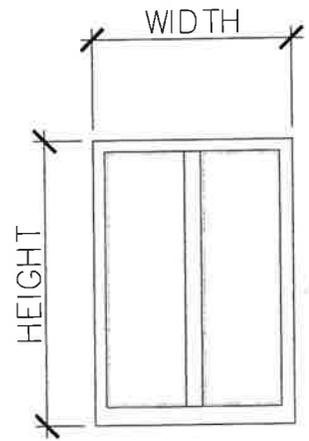
WINDOW				SPECIFIC CONDITION NOTES														
WINDOW NO. 102	EXPOSURE	TYPE A		EXTERIOR FINISH	INTERIOR FINISH	GLASS	FRAME	SASHES	HARDWARE	GLAZING MATERIAL	WEATHERSTRIPPING	SUPPORT MATERIAL	SILL	PERIMETER SEALANT				
A-102-E		METAL	S.G.	Good	Good	Good	Good	N/A	POOR	FAIR	FAIR	Good	FAIR	FAIR				
SCALE: 1/4" = 1'-0"				WINDOW SURVEY/WINDOW TYPES														
DATE:		JOB NO.: 2023.113		VAN ZANDT COUNTY COURTHOUSE														
				121 E. DALLAS STREET CANTON, TEXAS 75103														
														TYPE A				
														Sheet ___ of ___

① CLEAN/REPAINT

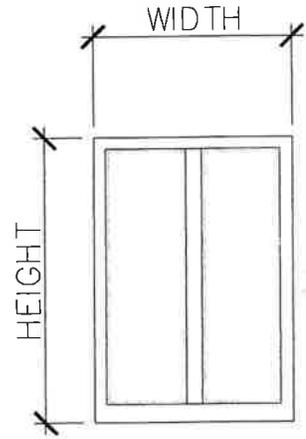
WINDOW				SPECIFIC CONDITION NOTES																		
WINDOW NO. 103	EXPOSURE	TYPE	A	EXTERIOR FINISH	INTERIOR FINISH	GLASS	FRAME	SASHES	HARDWARE	GLAZING MATERIAL	WEATHERSTRIPPING	SUPPORT MATERIAL	SILL	PERIMETER SEALANT								
A-103-E		METAL		GOOD	GOOD	GOOD	GOOD	N/A	✓	FAIR	FAIR	GOOD	FAIR	FAIR								
SCALE: 1/4" = 1'-0"				WINDOW SURVEY/WINDOW TYPES																		
DATE:		JOB NO.: 2023.113		VAN ZANDT COUNTY COURTHOUSE																		
				121 E. DALLAS STREET CANTON, TEXAS 75103																		
														TYPE A								
														Sheet ___ of ___

① CLEAN/REPAINT

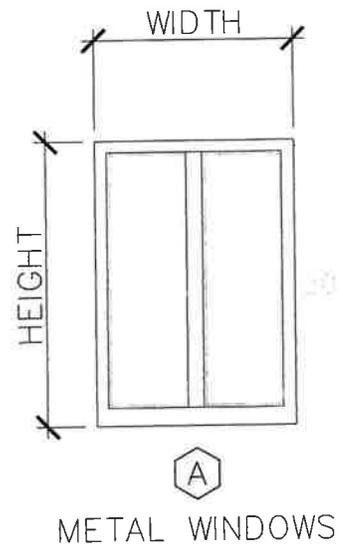
WINDOW		SPECIFIC CONDITION NOTES																			
WINDOW NO. 105	A	EXPOSURE	TYPE	FRAME MATERIAL	GLAZING MATERIAL	OVERALL CONDITION	EXTERIOR FINISH	INTERIOR FINISH	GLASS	FRAME	SASHES	HARDWARE	GLAZING MATERIAL	WEATHERSTRIPPING	SUPPORT MATERIAL	SILL	PERIMETER SEALANT				
A-105-E				METAL	S.G.	<i>Good</i>	<i>Good</i>		<i>Good</i>	<i>Good</i>	<i>N/A</i>		<i>FAIR</i>	<i>FAIR</i>	<i>Good</i>	<i>FAIR</i>	<i>FAIR</i>				
SCALE: 1/4" = 1'-0"		WINDOW SURVEY/WINDOW TYPES												TYPE A							
DATE:	JOB NO.: 2023.113	VAN ZANDT COUNTY COURTHOUSE																			
KOMATSU ARCHITECTURE		121 E. DALLAS STREET CANTON, TEXAS 75103												Sheet ___ of ___

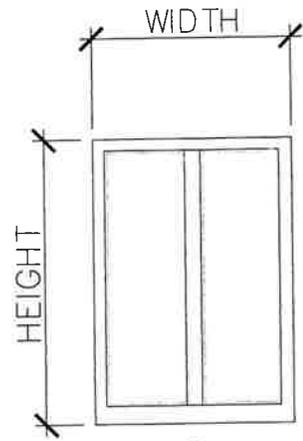
WINDOW			SPECIFIC CONDITION NOTES													
WINDOW NO. 107	EXPOSURE	TYPE A	EXTERIOR FINISH	INTERIOR FINISH	GLASS	FRAME	SASHES	HARDWARE	GLAZING MATERIAL	WEATHERSTRIPPING	SUPPORT MATERIAL	SILL	PERIMETER SEALANT			
A-107-N		METAL	Good	Good	Good	Good	N/A		FAIR	FAIR	Good	Good	FAIR			
SCALE: 1/4" = 1'-0"			WINDOW SURVEY/WINDOW TYPES													
DATE:		JOB NO.: 2023.113	VAN ZANDT COUNTY COURTHOUSE													
			121 E. DALLAS STREET CANTON, TEXAS 75103													
													TYPE A			
													Sheet ___ of ___

① CLEAN/REPAINT

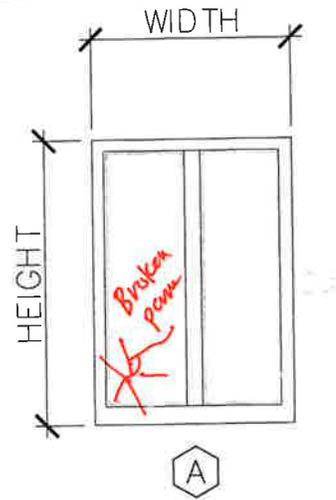
WINDOW				SPECIFIC CONDITION NOTES																			
WINDOW NO. 108	EXPOSURE	TYPE A																					
A-108-N	METAL	S.G.	GOOD	GOOD	GOOD/BAD	GOOD	N/A		BAD	BAD	GOOD	GOOD	FAIR										
SCALE: 1/4" = 1'-0"				WINDOW SURVEY/WINDOW TYPES																			
DATE:		JOB NO.: 2023.113		VAN ZANDT COUNTY COURTHOUSE																			
				121 E. DALLAS STREET CANTON, TEXAS 75103																			
				TYPE A																			
				Sheet ___ of ___

① CLEAN/REPAINT

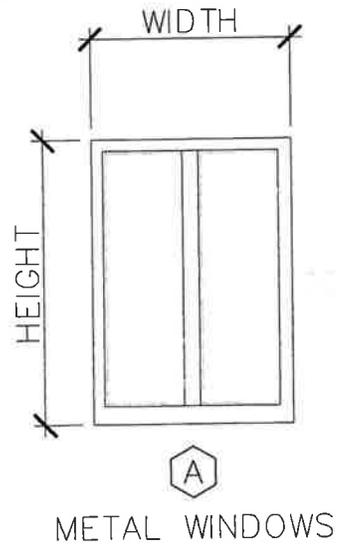
WINDOW				SPECIFIC CONDITION NOTES																			
WINDOW NO. 109	EXPOSURE	TYPE	A																				
A-109-N		METAL	S.G.	<i>Good</i>	<i>Good</i>	<i>Good</i>	<i>Good</i>	<i>N/A</i>	<i>BAD</i>	<i>BAD</i>	<i>Good</i>	<i>Good</i>	<i>FAIR</i>										
SCALE: 1/4" = 1'-0"				WINDOW SURVEY/WINDOW TYPES																			
DATE:		JOB NO.: 2023.113		VAN ZANDT COUNTY COURTHOUSE																			
KOMATSU ARCHITECTURE				121 E. DALLAS STREET CANTON, TEXAS 75103																			
				TYPE A																			
				Sheet ___ of ___

① CLEAN/REPAINT

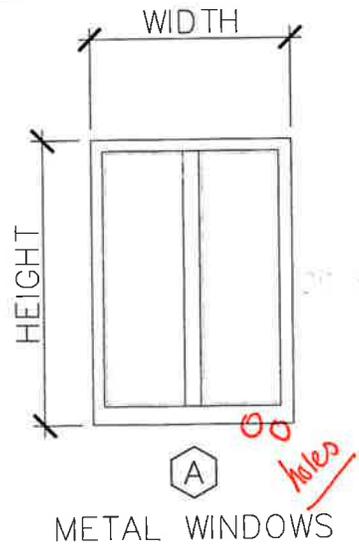
WINDOW				SPECIFIC CONDITION NOTES														
WINDOW NO. 110	EXPOSURE	TYPE	A	EXTERIOR FINISH	INTERIOR FINISH	GLASS	FRAME	SASHES	HARDWARE	GLAZING MATERIAL	WEATHERSTRIPPING	SUPPORT MATERIAL	SILL	PERIMETER SEALANT				
A-110-N		METAL	S.G.	<i>Good</i>	<i>Good</i>	<i>Good</i>	<i>Good</i>	<i>N/A</i>		<i>BAD</i>	<i>BAD</i>	<i>Good</i>	<i>Good</i>	<i>FAIR</i>				
SCALE: 1/4" = 1'-0"				WINDOW SURVEY/WINDOW TYPES														
DATE:		JOB NO.: 2023.113		VAN ZANDT COUNTY COURTHOUSE														
				121 E. DALLAS STREET CANTON, TEXAS 75103														
														TYPE A				
														Sheet ___ of ___

① CLEAN/REPAINT

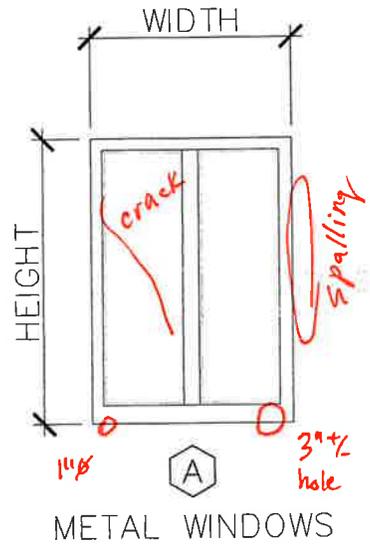
WINDOW		SPECIFIC CONDITION NOTES																
WINDOW NO. 111	A	EXTERIOR FINISH	INTERIOR FINISH	GLASS	FRAME	SASHES	HARDWARE	GLAZING MATERIAL	WEATHERSTRIPPING	SUPPORT MATERIAL	PERIMETER SEALANT							
A-111-N	FAIR	Good		<i>Left pane broken</i>	<i>BAD/Good</i>	<i>Good</i>	<i>N/A</i>	<i>BAD</i>	<i>BAD</i>	<i>FAIR</i>	<i>BAD</i>	<i>BAD</i>						
SCALE: 1/4" = 1'-0"		WINDOW SURVEY/WINDOW TYPES										TYPE A						
DATE:	JOB NO.: 2023.113	VAN ZANDT COUNTY COURTHOUSE										Sheet ___ of ___						
KOMATSU ARCHITECTURE		121 E. DALLAS STREET CANTON, TEXAS 75103

① CLEAN/REPAINT

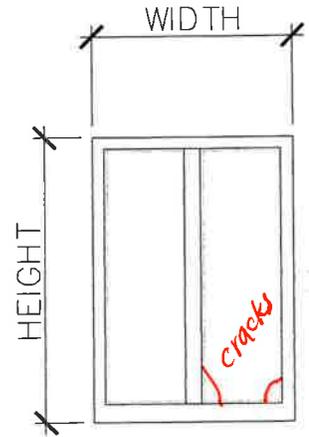
WINDOW		SPECIFIC CONDITION NOTES																				
WINDOW NO. 112	EXPOSURE	A																				
	TYPE																					
	FRAME MATERIAL																					
	GLAZING MATERIAL																					
	OVERALL CONDITION																					
	EXTERIOR FINISH																					
	INTERIOR FINISH																					
	GLASS																					
	FRAME																					
	SASHES																					
	HARDWARE																					
	GLAZING MATERIAL																					
	WEATHERSTRIPPING																					
	SUPPORT MATERIAL																					
	SILL																					
	PERIMETER SEALANT																					
A-112-N			METAL	S.G.	Good	Good	Good/Bad	Good	N/A	FAIR	FAIR	Good	Good	FAIR								
SCALE: 1/4" = 1'-0"		WINDOW SURVEY/WINDOW TYPES												TYPE A								
DATE:	JOB NO.: 2023.113	VAN ZANDT COUNTY COURTHOUSE																				
		121 E. DALLAS STREET CANTON, TEXAS 75103												Sheet ___ of ___

① CLEAN/REPAINT

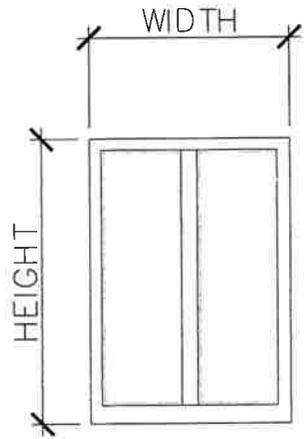
WINDOW				SPECIFIC CONDITION NOTES																			
WINDOW NO. 113	EXPOSURE	TYPE	A																				
A-113-N		METAL	S.G.	Good	EXTERIOR FINISH	INTERIOR FINISH	GLASS	FRAME	SASHES	HARDWARE	GLAZING MATERIAL	WEATHERSTRIPPING	SUPPORT MATERIAL	SILL	PERIMETER SEALANT								
				Good	Good	Good	Good	Good	N/A	-	FAIR	FAIR	Good	Good	FAIR								
SCALE: 1/4" = 1'-0"				WINDOW SURVEY/WINDOW TYPES																			
DATE:		JOB NO.: 2023.113		VAN ZANDT COUNTY COURTHOUSE																			
KOMATSU ARCHITECTURE				121 E. DALLAS STREET CANTON, TEXAS 75103																			
				TYPE A																			
				Sheet ___ of ___

① CLEAN/REPAINT

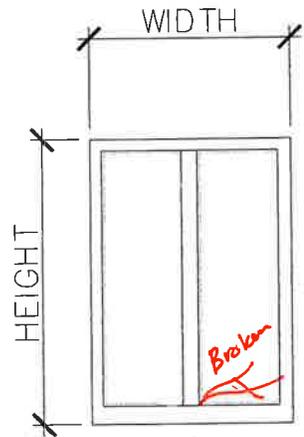
WINDOW				SPECIFIC CONDITION NOTES																		
WINDOW NO. 114	EXPOSURE	TYPE A		EXTERIOR FINISH	INTERIOR FINISH	GLASS	FRAME	SASHES	HARDWARE	GLAZING MATERIAL	WEATHERSTRIPPING	SUPPORT MATERIAL	SILL	PERIMETER SEALANT								
A-114-N		METAL	S.G.	Good	Good	Good/Bad	Good	N/A		FAIR	FAIR	Good	Good	FAIR								
SCALE: 1/4" = 1'-0"				WINDOW SURVEY/WINDOW TYPES																		
DATE:		JOB NO.: 2023.113		VAN ZANDT COUNTY COURTHOUSE																		
				121 E. DALLAS STREET CANTON, TEXAS 75103																		
TYPE A																						
Sheet ___ of ___

① CLEAN/REPAINT

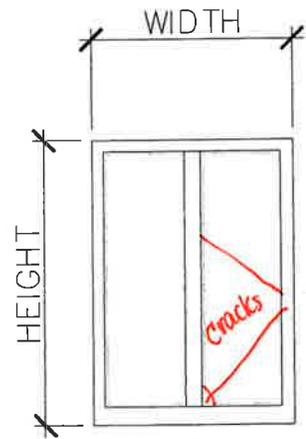
WINDOW				SPECIFIC CONDITION NOTES																			
WINDOW NO. 115	EXPOSURE	TYPE A	A	EXTERIOR FINISH	INTERIOR FINISH	GLASS	FRAME	SASHES	HARDWARE	GLAZING MATERIAL	WEATHERSTRIPPING	SUPPORT MATERIAL	SILL	PERIMETER SEALANT									
A-115-N				Good	Good	Good/Bad <i>Rt. Pane to be replaced</i>	Good	N/A		FAIR	FAIR	Good	Good	FAIR									
SCALE: 1/4" = 1'-0"				WINDOW SURVEY/WINDOW TYPES																			
DATE:		JOB NO.: 2023.113		VAN ZANDT COUNTY COURTHOUSE																			
				121 E. DALLAS STREET CANTON, TEXAS 75103																			
				TYPE A																			
				Sheet ___ of ___

① CLEAN/REPAINT

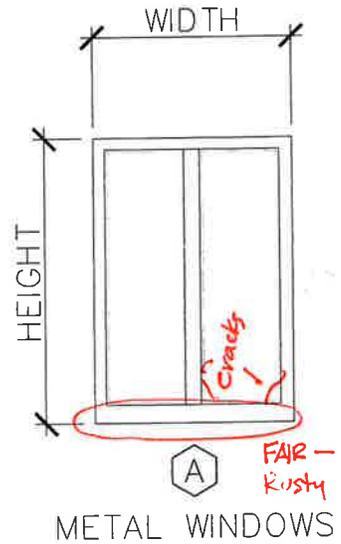
WINDOW		SPECIFIC CONDITION NOTES																
WINDOW NO. 116	A	EXTERIOR FINISH	INTERIOR FINISH	GLASS	FRAME	SASHES	HARDWARE	GLAZING MATERIAL	WEATHERSTRIPPING	SUPPORT MATERIAL	SILL	PERIMETER SEALANT						
A-116-W		Good	Good	Rt. pane broken - Good/BAD	Good	N/A		FAIR	FAIR	Good	FAIR	FAIR						
SCALE: 1/4" = 1'-0"		WINDOW SURVEY/WINDOW TYPES																
DATE:	JOB NO.: 2023.113	VAN ZANDT COUNTY COURTHOUSE																
		121 E. DALLAS STREET CANTON, TEXAS 75103																
		TYPE A																
		Sheet ___ of ___

① CLEAN/REPAINT

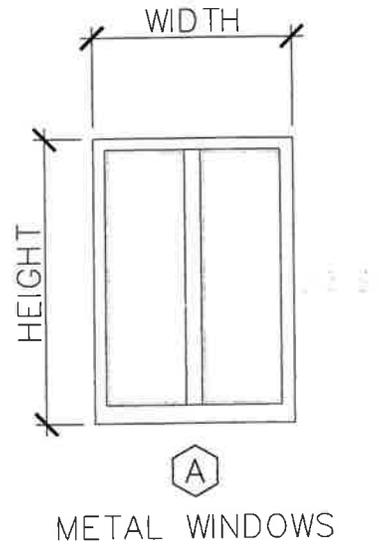
WINDOW				SPECIFIC CONDITION NOTES																			
WINDOW NO. 117	EXPOSURE	TYPE	A																				
FRAME MATERIAL	GLAZING MATERIAL	OVERALL CONDITION		EXTERIOR FINISH	INTERIOR FINISH	GLASS	FRAME	SASHES	HARDWARE	GLAZING MATERIAL	WEATHERSTRIPPING	SUPPORT MATERIAL	SILL	PERIMETER SEALANT									
METAL	S.G.	<i>Good</i>		<i>Good</i>		<i>Good</i>	<i>Good</i>	<i>N/A</i>		<i>FAIR</i>	<i>FAIR</i>	<i>Good</i>	<i>Good</i>	<i>FAIR</i>									
SCALE: 1/4" = 1'-0"				WINDOW SURVEY/WINDOW TYPES																			
DATE:		JOB NO.: 2023.113		VAN ZANDT COUNTY COURTHOUSE																			
KOMATSU ARCHITECTURE				121 E. DALLAS STREET CANTON, TEXAS 75103																			
				TYPE A																			
				Sheet ___ of ___

① CLEAN/REPAINT

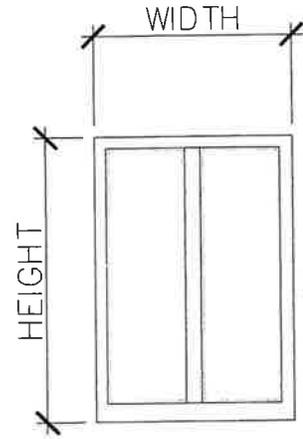
WINDOW				SPECIFIC CONDITION NOTES																			
WINDOW NO. 118	EXPOSURE	TYPE	A																				
FRAME MATERIAL	GLAZING MATERIAL	OVERALL CONDITION		EXTERIOR FINISH	INTERIOR FINISH	GLASS	FRAME	SASHES	HARDWARE	GLAZING MATERIAL	WEATHERSTRIPPING	SUPPORT MATERIAL	SILL	PERIMETER SEALANT									
METAL	S.G.	<i>Good</i>		<i>Good</i>		<i>Good</i>	<i>Good</i>	<i>N/A</i>		<i>FAIR</i>	<i>FAIR</i>	<i>Good</i>	<i>Good</i>	<i>FAIR</i>									
SCALE: 1/4" = 1'-0"				WINDOW SURVEY/WINDOW TYPES																			
DATE:		JOB NO.: 2023.113		VAN ZANDT COUNTY COURTHOUSE										TYPE A									
				121 E. DALLAS STREET CANTON, TEXAS 75103										Sheet ___ of ___

① CLEAN/REPAINT

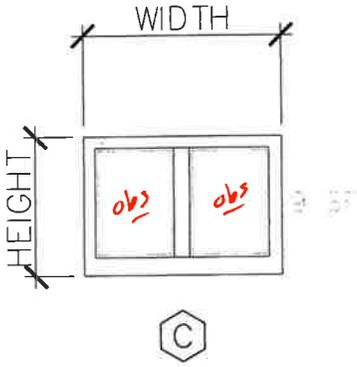
WINDOW				SPECIFIC CONDITION NOTES																			
WINDOW NO.	EXPOSURE	TYPE	C	EXTERIOR FINISH	INTERIOR FINISH	GLASS	FRAME	SASHES	HARDWARE	GLAZING MATERIAL	WEATHERSTRIPPING	SUPPORT MATERIAL	SILL	PERIMETER SEALANT									
C-119-W				Good		Obscured	Good	N/A		BAD	BAD	Good	Group	FAIR									
SCALE: 1/4" = 1'-0" DATE: _____ JOB NO.: 2023.113				WINDOW SURVEY/WINDOW TYPES VAN ZANDT COUNTY COURTHOUSE 121 E. DALLAS STREET CANTON, TEXAS 75103												TYPE C Sheet ___ of ___

① CLEAN/REPAINT

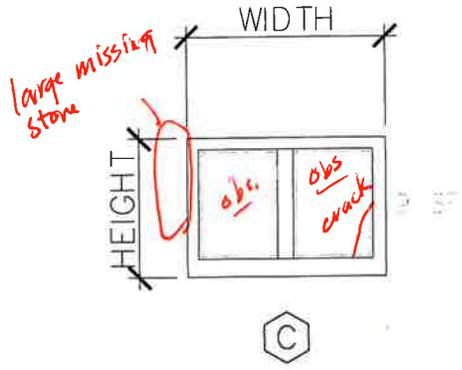
WINDOW		SPECIFIC CONDITION NOTES																															
WINDOW NO.	120	EXPOSURE		TYPE	C	EXTERIOR FINISH		INTERIOR FINISH		GLASS		FRAME		SASHES		HARDWARE		GLAZING MATERIAL		WEATHERSTRIPPING		SUPPORT MATERIAL		SILL		PERIMETER SEALANT							
C-120-W						Good		Good		Good/BAD		Good		N/A				BAD		BAD		Good		Good		FAIR							
SCALE: 1/4" = 1'-0"		WINDOW SURVEY/WINDOW TYPES										TYPE C																					
DATE:		JOB NO.:	2023.113			VAN ZANDT COUNTY COURTHOUSE																											
		121 E. DALLAS STREET CANTON, TEXAS 75103										Sheet ___ of ___

Rt. Pane to be replaced obscured

support above panel in front is spalled

① CLEAN/REPAINT

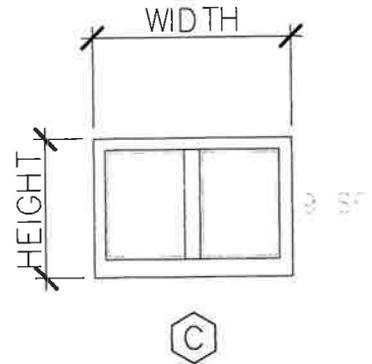
WINDOW		SPECIFIC CONDITION NOTES																	
WINDOW NO. 121	EXPOSURE	TYPE	FRAME MATERIAL	GLAZING MATERIAL	OVERALL CONDITION	EXTERIOR FINISH	INTERIOR FINISH	GLASS	FRAME	SASHES	HARDWARE	GLAZING MATERIAL	WEATHERSTRIPPING	SUPPORT MATERIAL	SILL	PERIMETER SEALANT			
C-121-W		C	METAL	S.G.	<i>Good</i>	<i>Good</i>		<i>Good</i>	<i>Good</i>	<i>N/A</i>		<i>BAD</i>	<i>BAD</i>	<i>Good</i>	<i>Good</i>	<i>FAIR</i>			
SCALE: 1/4" = 1'-0"		WINDOW SURVEY/WINDOW TYPES												TYPE C					
DATE:	JOB NO.: 2023.113	VAN ZANDT COUNTY COURTHOUSE																	
		121 E. DALLAS STREET CANTON, TEXAS 75103												Sheet ___ of ___

① CLEAN/REPAINT

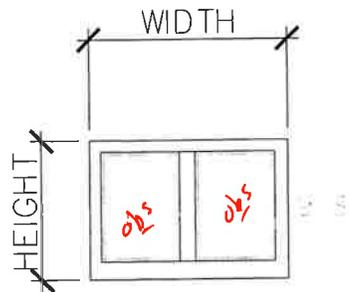
WINDOW				SPECIFIC CONDITION NOTES																	
WINDOW NO.	EXPOSURE	TYPE		EXTERIOR FINISH	INTERIOR FINISH	GLASS	FRAME	SASHES	HARDWARE	GLAZING MATERIAL	WEATHERSTRIPPING	SUPPORT MATERIAL	SILL	PERIMETER SEALANT							
C-122-S		C		Good		obscured	Good	N/A		BAD	BAD	Good	Good	FAIR							
SCALE: 1/4" = 1'-0"				WINDOW SURVEY/WINDOW TYPES																	
DATE:		JOB NO.: 2023.113		VAN ZANDT COUNTY COURTHOUSE																	
				121 E. DALLAS STREET CANTON, TEXAS 75103																	
TYPE C																					
Sheet ___ of ___

① CLEAN/REPAINT

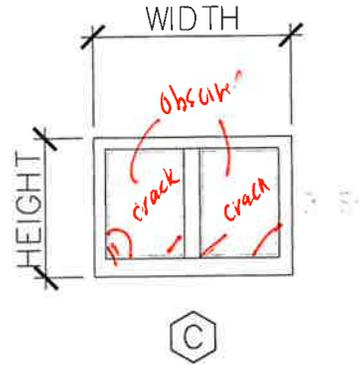
WINDOW						SPECIFIC CONDITION NOTES																	
WINDOW NO.	EXPOSURE	TYPE	FRAME MATERIAL	GLAZING MATERIAL	OVERALL CONDITION	EXTERIOR FINISH	INTERIOR FINISH	GLASS	FRAME	SASHES	HARDWARE	GLAZING MATERIAL	WEATHERSTRIPPING	SUPPORT MATERIAL	SILL	PERIMETER SEALANT							
C-123-S		C	METAL	S.G.	Good	Good		Replace Both panes	Good	N/A		BAD	BAD	Good	Good	FAIR							
SCALE: 1/4" = 1'-0"						WINDOW SURVEY/WINDOW TYPES																	
DATE:						JOB NO.: 2023.113						VAN ZANDT COUNTY COURTHOUSE						TYPE C					
						121 E. DALLAS STREET CANTON, TEXAS 75103						Sheet ___ of ___

① CLEAN/REPAINT

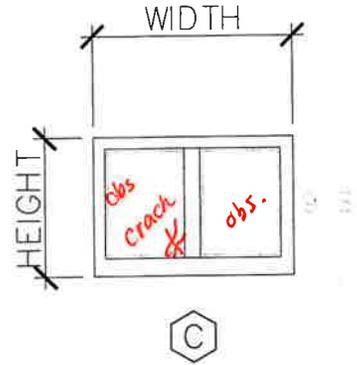
WINDOW				SPECIFIC CONDITION NOTES																
WINDOW NO. 124	EXPOSURE	TYPE C		EXTERIOR FINISH	INTERIOR FINISH	GLASS	FRAME	SASHES	HARDWARE	GLAZING MATERIAL	WEATHERSTRIPPING	SUPPORT MATERIAL	SILL	PERIMETER SEALANT						
C-124-S			METAL	S.G.	Good	Good	Bad/Good	Good	N/A	Bad	Bad	Good	Good	FAIR						
SCALE: 1/4" = 1'-0"				WINDOW SURVEY/WINDOW TYPES										TYPE C						
DATE:		JOB NO.: 2023.113		VAN ZANDT COUNTY COURTHOUSE																
				121 E. DALLAS STREET CANTON, TEXAS 75103										Sheet ___ of ___

① CLEAN/REPAINT

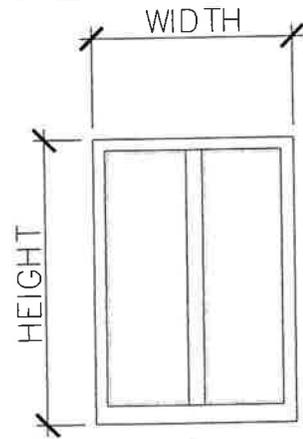
WINDOW				SPECIFIC CONDITION NOTES																			
WINDOW NO. 131	EXPOSURE	TYPE	A	EXTERIOR FINISH	INTERIOR FINISH	GLASS	FRAME	SASHES	HARDWARE	GLAZING MATERIAL	WEATHERSTRIPPING	SUPPORT MATERIAL	SILL	PERIMETER SEALANT									
A-131-S		METAL		FAIR	FAIR	Good	Good	N/A		BAD	BAD	Good	Good	FAIR									
SCALE: 1/4" = 1'-0"				WINDOW SURVEY/WINDOW TYPES																			
DATE:		JOB NO.: 2023.113		VAN ZANDT COUNTY COURTHOUSE																			
				121 E. DALLAS STREET CANTON, TEXAS 75103																			
				TYPE A																			
				Sheet ___ of ___

① CLEAN/REPAINT

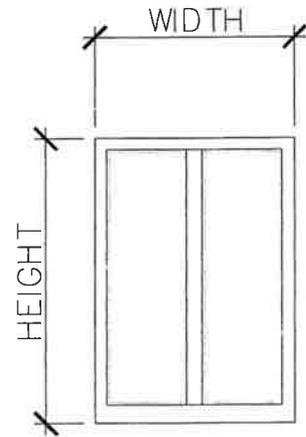
WINDOW						SPECIFIC CONDITION NOTES																	
WINDOW NO. 133	EXPOSURE	TYPE	FRAME MATERIAL	GLAZING MATERIAL	OVERALL CONDITION	EXTERIOR FINISH	INTERIOR FINISH	GLASS	FRAME	SASHES	HARDWARE	GLAZING MATERIAL	WEATHERSTRIPPING	SUPPORT MATERIAL	SILL	PERIMETER SEALANT							
A-133-S		A	METAL	S.G.	FAIR	FAIR		Good	Good	N/A		BAD	BAD	Good	FAIR	FAIR							
SCALE: 1/4" = 1'-0"						WINDOW SURVEY/WINDOW TYPES																	
DATE:		JOB NO.: 2023.113				VAN ZANDT COUNTY COURTHOUSE																	
KOMATSU ARCHITECTURE						121 E. DALLAS STREET CANTON, TEXAS 75103						<h2 style="margin: 0;">TYPE A</h2> Sheet ___ of ___

① CLEAN/REPAINT

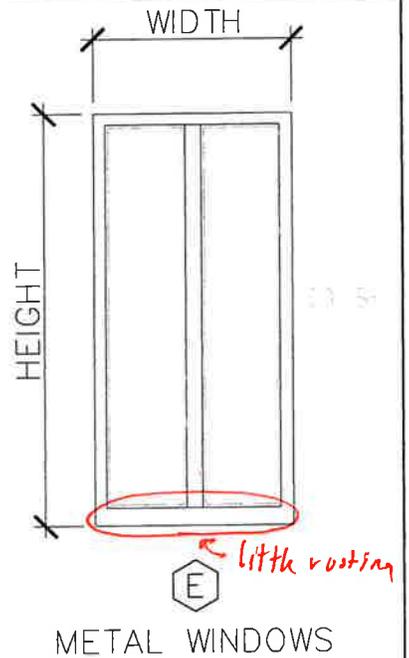
WINDOW				SPECIFIC CONDITION NOTES																			
WINDOW NO. 201	EXPOSURE	TYPE E																					
E-201-E		METAL	S.G.	<i>Good</i>	<i>Good</i>	<i>Good</i>	<i>Good</i>	<i>N/A</i>		<i>Bad</i>	<i>Bad</i>	<i>Good</i>	<i>FAIR</i>	<i>Bad</i>									
SCALE: 1/4" = 1'-0"				WINDOW SURVEY/WINDOW TYPES																			
DATE:		JOB NO.: 2023.113		VAN ZANDT COUNTY COURTHOUSE																			
				121 E. DALLAS STREET CANTON, TEXAS 75103																			
				TYPE E																			
				Sheet ___ of ___

① CLEAN/REPAINT

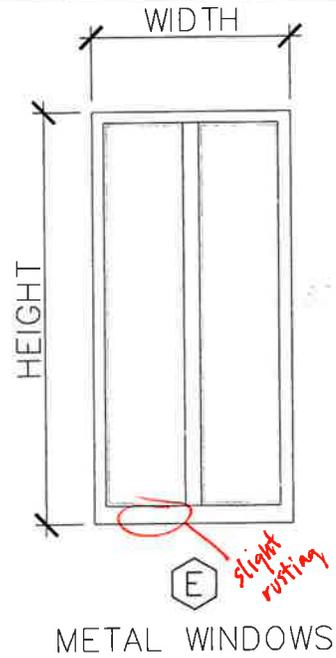
WINDOW				SPECIFIC CONDITION NOTES																	
WINDOW NO.	EXPOSURE	TYPE		EXTERIOR FINISH	INTERIOR FINISH	GLASS	FRAME	SASHES	HARDWARE	GLAZING MATERIAL	WEATHERSTRIPPING	SUPPORT MATERIAL	SILL	PERIMETER SEALANT							
E-202-E		E		Good	Good	Good	Good	N/A		BAD	BAD	Good	FAIR	BAD							
SCALE: 1/4" = 1'-0"				WINDOW SURVEY/WINDOW TYPES										TYPE E							
DATE:		JOB NO.: 2023.113		VAN ZANDT COUNTY COURTHOUSE																	
				121 E. DALLAS STREET CANTON, TEXAS 75103										Sheet ___ of ___

① CLEAN/REPAINT

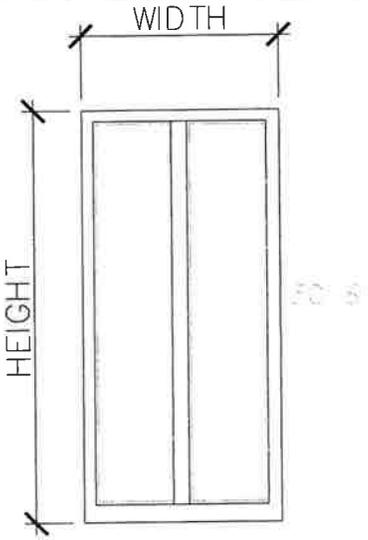
WINDOW				SPECIFIC CONDITION NOTES																				
WINDOW NO. 203	EXPOSURE	TYPE	E																					
E-203-E				METAL	S.G.	Good		Good	Good	Good	N/A		BAD	BAD	Good	Good	BAD							
SCALE: 1/4" = 1'-0"				WINDOW SURVEY/WINDOW TYPES																				
DATE:		JOB NO.: 2023.113		VAN ZANDT COUNTY COURTHOUSE																				
KOMATSU ARCHITECTURE				121 E. DALLAS STREET CANTON, TEXAS 75103																				
				TYPE E																				
				Sheet ___ of ___

① CLEAN/REPAINT

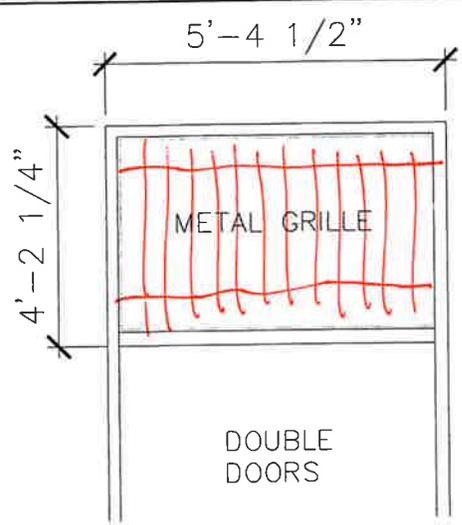
WINDOW					SPECIFIC CONDITION NOTES															
WINDOW NO. 204	EXPOSURE	TYPE G	FRAME MATERIAL	GLAZING MATERIAL	OVERALL CONDITION	EXTERIOR FINISH	INTERIOR FINISH	GLASS	FRAME	SASHES	HARDWARE	GLAZING MATERIAL	WEATHERSTRIPPING	SUPPORT MATERIAL	SILL	PERIMETER SEALANT				
G-204-E			METAL	S.G.	Good	Good	Good	Good	Good	N/A		Good	Good	Good	Good	Good				
SCALE: 1/4" = 1'-0"					WINDOW SURVEY/WINDOW TYPES															
DATE:		JOB NO.: 2023.113			VAN ZANDT COUNTY COURTHOUSE															
KOMATSU ARCHITECTURE					121 E. DALLAS STREET CANTON, TEXAS 75103															
															TYPE G					
															Sheet__of__

① CLEAN/REPAINT

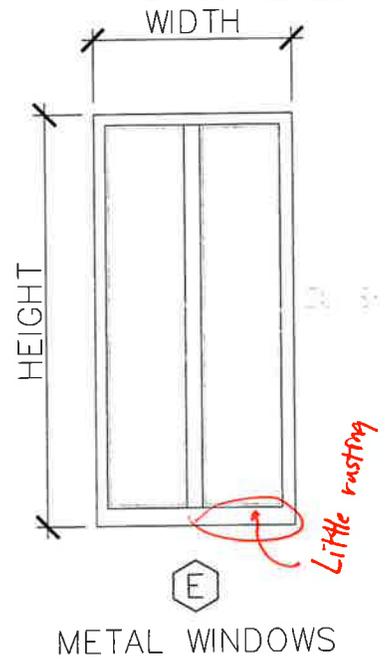
WINDOW		SPECIFIC CONDITION NOTES															
WINDOW NO. 205	EXPOSURE	TYPE E	EXTERIOR FINISH	INTERIOR FINISH	GLASS	FRAME	SASHES	HARDWARE	GLAZING MATERIAL	WEATHERSTRIPPING	SUPPORT MATERIAL	SILL	PERIMETER SEALANT				
E-205-E		METAL	S.G.	GOOD	GOOD	GOOD	GOOD	N/A	BAD	BAD	GOOD	GOOD	BAD				
SCALE: 1/4" = 1'-0"		WINDOW SURVEY/WINDOW TYPES															
DATE:	JOB NO.: 2023.113	VAN ZANDT COUNTY COURTHOUSE															
		121 E. DALLAS STREET CANTON, TEXAS 75103															
		TYPE E															
		Sheet ___ of ___

① CLEAN/REPAINT

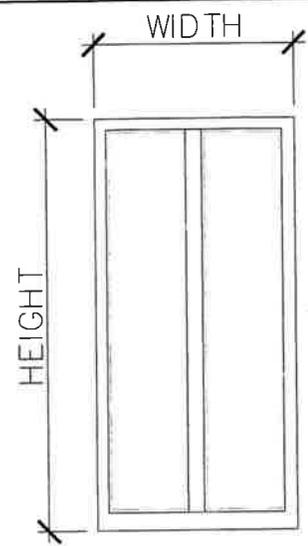
WINDOW		SPECIFIC CONDITION NOTES																				
WINDOW NO. 207	EXPOSURE	TYPE	E																			
E-207-E		METAL	S.G.	Good	Good	Good	Good	N/A	BAD	BAD	Good	Good	BAD									
SCALE: 1/4" = 1'-0"		WINDOW SURVEY/WINDOW TYPES																				
DATE:	JOB NO.: 2023.113	VAN ZANDT COUNTY COURTHOUSE

① CLEAN/REPAINT

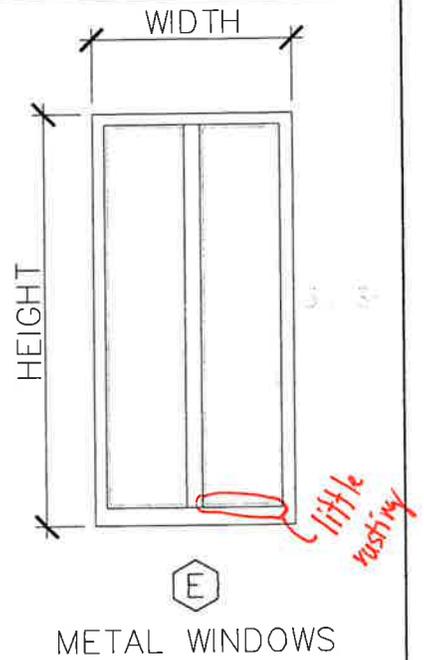
WINDOW		SPECIFIC CONDITION NOTES																		
WINDOW NO. 208	EXPOSURE	TYPE E	FRAME MATERIAL	GLAZING MATERIAL	OVERALL CONDITION	EXTERIOR FINISH	INTERIOR FINISH	GLASS	FRAME	SASHES	HARDWARE	GLAZING MATERIAL	WEATHERSTRIPPING	SUPPORT MATERIAL	SILL	PERIMETER SEALANT				
E-208-N			METAL	S.G.	Good	Good		Good	Good	N/A		BAD	BAD	Good	Good	BAD				
SCALE: 1/4" = 1'-0"		WINDOW SURVEY/WINDOW TYPES										TYPE E								
DATE:	JOB NO.: 2023.113	VAN ZANDT COUNTY COURTHOUSE																		
		121 E. DALLAS STREET CANTON, TEXAS 75103										Sheet ___ of ___

① CLEAN/REPAINT

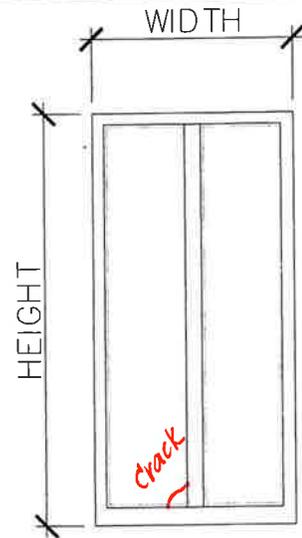
WINDOW				SPECIFIC CONDITION NOTES																	
WINDOW NO. 209	EXPOSURE	TYPE	E	EXTERIOR FINISH	INTERIOR FINISH	GLASS	FRAME	SASHES	HARDWARE	GLAZING MATERIAL	WEATHERSTRIPPING	SUPPORT MATERIAL	SILL	PERIMETER SEALANT							
E-209-N		METAL		S.G.	Good	Good	Good/BAD <i>left pane needs replaced - cracked</i>	Good	N/A	BAD	BAD	Good	Good	BAD							
SCALE: 1/4" = 1'-0"				WINDOW SURVEY/WINDOW TYPES										TYPE E							
DATE:		JOB NO.: 2023.113		VAN ZANDT COUNTY COURTHOUSE																	
				121 E. DALLAS STREET CANTON, TEXAS 75103										Sheet ___ of ___

① CLEAN/REPAINT

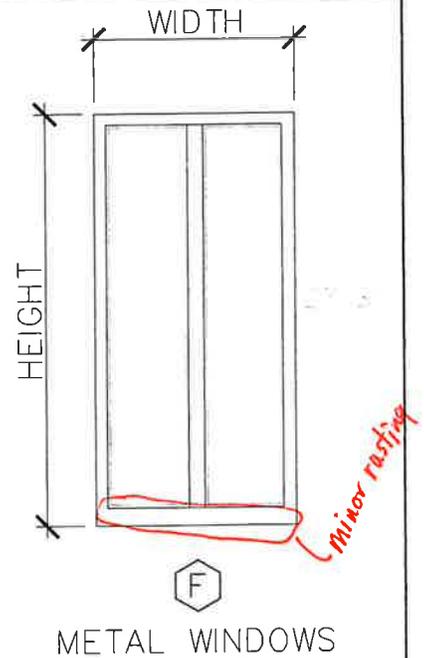
WINDOW		SPECIFIC CONDITION NOTES																				
WINDOW NO. 211	EXPOSURE	TYPE	FRAME MATERIAL	GLAZING MATERIAL	OVERALL CONDITION	EXTERIOR FINISH	INTERIOR FINISH	GLASS	FRAME	SASHES	HARDWARE	GLAZING MATERIAL	WEATHERSTRIPPING	SUPPORT MATERIAL	SILL	PERIMETER SEALANT						
F-211-N		F	METAL	S.G.	Good	Good	Good	Good	Good	N/A		BAD	BAD	Good	FAIR	BAD						
SCALE: 1/4" = 1'-0"		WINDOW SURVEY/WINDOW TYPES												TYPE F								
DATE:		JOB NO.: 2023.113		VAN ZANDT COUNTY COURTHOUSE												Sheet ___ of ___						
KOMATSU ARCHITECTURE		121 E. DALLAS STREET CANTON, TEXAS 75103

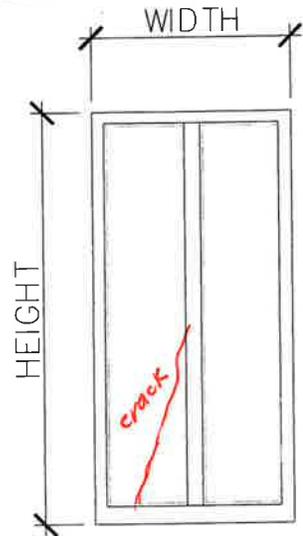
WINDOW			SPECIFIC CONDITION NOTES																		
WINDOW NO. 212	EXPOSURE	TYPE																			
F-212-N		F	METAL	S.G.	<i>Good</i>	<i>Good</i>	<i>Bad/Good</i>	<i>Good</i>	<i>N/A</i>	<i>Bad</i>	<i>Bad</i>	<i>Good</i>	<i>Good</i>	<i>Bad</i>							
			FRAME MATERIAL	GLAZING MATERIAL	OVERALL CONDITION	EXTERIOR FINISH	INTERIOR FINISH	GLASS	FRAME	SASHES	HARDWARE	GLAZING MATERIAL	WEATHERSTRIPPING	SUPPORT MATERIAL	SILL	PERIMETER SEALANT					
								<i>Left pane to be replaced</i>													
SCALE: 1/4" = 1'-0"			WINDOW SURVEY/WINDOW TYPES										TYPE F								
DATE:		JOB NO.: 2023.113		VAN ZANDT COUNTY COURTHOUSE										Sheet__of__							
				121 E. DALLAS STREET CANTON, TEXAS 75103																	
KOMATSU ARCHITECTURE

① CLEAN/REPAINT

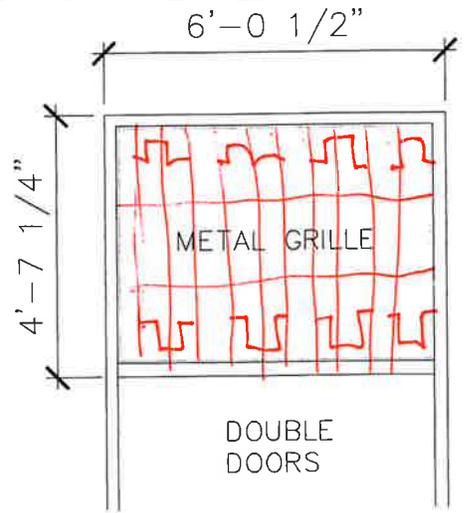
WINDOW		SPECIFIC CONDITION NOTES																	
WINDOW NO. 213	EXPOSURE	TYPE	FRAME MATERIAL	GLAZING MATERIAL	OVERALL CONDITION	EXTERIOR FINISH	INTERIOR FINISH	GLASS	FRAME	SASHES	HARDWARE	GLAZING MATERIAL	WEATHERSTRIPPING	SUPPORT MATERIAL	SILL	PERIMETER SEALANT			
H-213-N		H	METAL	S.G.	Good	Good		Good	Good	N/A		FAIR	FAIR	Good	Good	FAIR			
SCALE: 1/4" = 1'-0"		WINDOW SURVEY/WINDOW TYPES												<p>TYPE H</p> <p>Sheet__of__</p>					
DATE:	JOB NO.: 2023.113	<p>VAN ZANDT COUNTY COURTHOUSE</p> <p>121 E. DALLAS STREET CANTON, TEXAS 75103</p>

① CLEAN/REPAINT

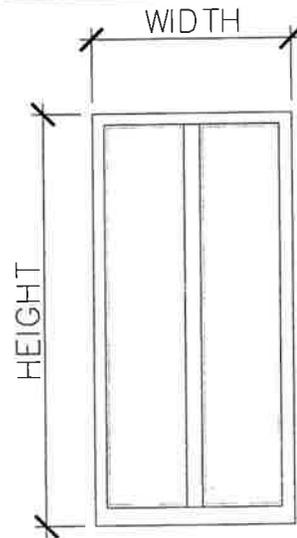
WINDOW					SPECIFIC CONDITION NOTES																		
WINDOW NO.	EXPOSURE	TYPE	FRAME MATERIAL	GLAZING MATERIAL	OVERALL CONDITION	EXTERIOR FINISH	INTERIOR FINISH	GLASS	FRAME	SASHES	HARDWARE	GLAZING MATERIAL	WEATHERSTRIPPING	SUPPORT MATERIAL	SILL	PERIMETER SEALANT							
F-214-N		F	METAL	S.G.	Good	Good		Good	Good	N/A		BAD	BAD	Good	Good	BAD							
SCALE: 1/4" = 1'-0"					WINDOW SURVEY/WINDOW TYPES																		
DATE:		JOB NO.: 2023.113			VAN ZANDT COUNTY COURTHOUSE																		
					121 E. DALLAS STREET CANTON, TEXAS 75103																		
TYPE F																							
Sheet ___ of ___

① CLEAN/REPAINT

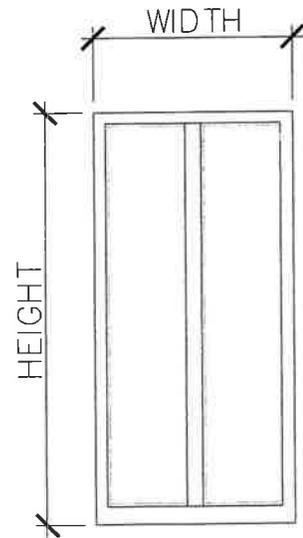
WINDOW				SPECIFIC CONDITION NOTES												
WINDOW NO.	EXPOSURE	TYPE	FRAME MATERIAL	GLAZING MATERIAL	OVERALL CONDITION	EXTERIOR FINISH	INTERIOR FINISH	GLASS	FRAME	SASHES	HARDWARE	GLAZING MATERIAL	WEATHERSTRIPPING	SUPPORT MATERIAL	SILL	PERIMETER SEALANT
F-215-N		F	METAL	S.G.	Good	Good		Good	Good	N/A		BAD	BAD	Good	Good	BAD
												Repl.	Repl.			Repl.

① CLEAN/REPAINT

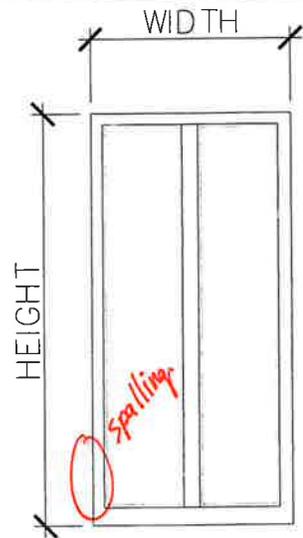
WINDOW		SPECIFIC CONDITION NOTES															
WINDOW NO. 216	F	EXTERIOR FINISH	INTERIOR FINISH	GLASS	FRAME	SASHES	HARDWARE	GLAZING MATERIAL	WEATHERSTRIPPING	SUPPORT MATERIAL	PERIMETER SEALANT						
F-216-N		Good	Good	Good	Good	N/A		BAD	BAD	Good/Fair <i>bottom left spalling</i>	Good	BAD					
SCALE: 1/4" = 1'-0"		WINDOW SURVEY/WINDOW TYPES										TYPE F					
DATE:		JOB NO.: 2023.113										VAN ZANDT COUNTY COURTHOUSE					
KOMATSU ARCHITECTURE		121 E. DALLAS STREET CANTON, TEXAS 75103										Sheet ___ of ___

① CLEAN/REPAINT

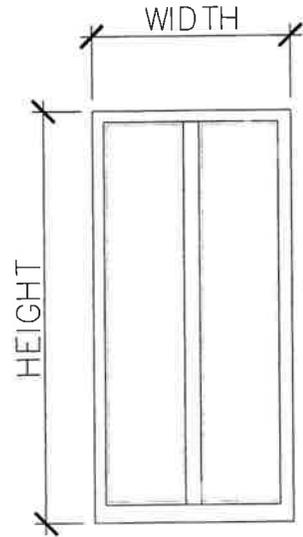
WINDOW						SPECIFIC CONDITION NOTES															
WINDOW NO.	EXPOSURE	TYPE	FRAME MATERIAL	GLAZING MATERIAL	OVERALL CONDITION	EXTERIOR FINISH	INTERIOR FINISH	GLASS	FRAME	SASHES	HARDWARE	GLAZING MATERIAL	WEATHERSTRIPPING	SUPPORT MATERIAL	SILL	PERIMETER SEALANT					
E-217-N		E	METAL	S.G.	Good	Good		Good	Good	N/A		BAD	BAD	Good	Good	BAD					
SCALE: 1/4" = 1'-0"						WINDOW SURVEY/WINDOW TYPES															
DATE:		JOB NO.: 2023.113				VAN ZANDT COUNTY COURTHOUSE															
						121 E. DALLAS STREET CANTON, TEXAS 75103															
TYPE E																					
Sheet ___ of ___

① CLEAN/REPAINT

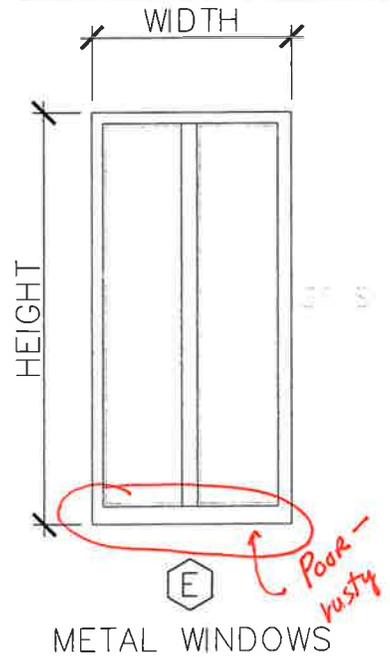
WINDOW					SPECIFIC CONDITION NOTES															
WINDOW NO. 218	EXPOSURE	TYPE E	FRAME MATERIAL	GLAZING MATERIAL	OVERALL CONDITION	EXTERIOR FINISH	INTERIOR FINISH	GLASS	FRAME	SASHES	HARDWARE	GLAZING MATERIAL	WEATHERSTRIPPING	SUPPORT MATERIAL	SILL	PERIMETER SEALANT				
E-218-N			METAL	S.G.	Good	Good		Good	Good	N/A		BAD	BAD	Good	Poor	BAD				
SCALE: 1/4" = 1'-0"					WINDOW SURVEY/WINDOW TYPES															
DATE:		JOB NO.: 2023.113			VAN ZANDT COUNTY COURTHOUSE										TYPE E					
					121 E. DALLAS STREET CANTON, TEXAS 75103												Sheet ___ of ___

① CLEAN/REPAINT

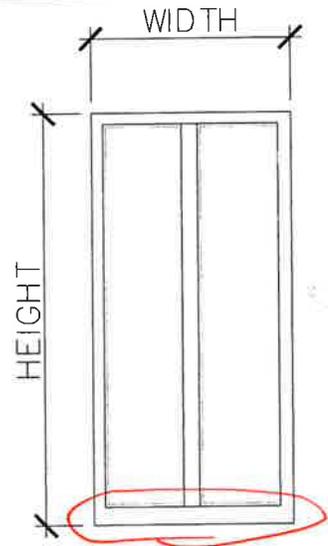
① **E Rusty**
METAL WINDOWS

WINDOW						SPECIFIC CONDITION NOTES																		
WINDOW NO. 219	EXPOSURE	TYPE	E	FRAME MATERIAL	GLAZING MATERIAL	OVERALL CONDITION	EXTERIOR FINISH	INTERIOR FINISH	GLASS	FRAME	SASHES	HARDWARE	GLAZING MATERIAL	WEATHERSTRIPPING	SUPPORT MATERIAL	SILL	PERIMETER SEALANT							
E-219-W				METAL	S.G.	Good	Good		Good	Good	N/A		BAD	BAD	Good	FAIR	BAD							
SCALE: 1/4" = 1'-0"						WINDOW SURVEY/WINDOW TYPES																		
DATE:		JOB NO.: 2023.113				VAN ZANDT COUNTY COURTHOUSE																		
KOMATSU ARCHITECTURE						121 E. DALLAS STREET CANTON, TEXAS 75103																		
TYPE E																								
Sheet ___ of ___

① CLEAN/REPAINT

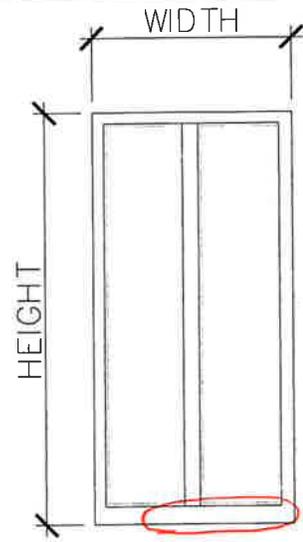
WINDOW		SPECIFIC CONDITION NOTES														
WINDOW NO.	220	EXTERIOR FINISH	INTERIOR FINISH	GLASS	FRAME	SASHES	HARDWARE	GLAZING MATERIAL	WEATHERSTRIPPING	SUPPORT MATERIAL	SILL	PERIMETER SEALANT				
E-220-W	E	Good	Good	Good	Good	N/A		BAD	BAD	Good	FAIR	BAD				
EXPOSURE		FRAME MATERIAL	GLAZING MATERIAL	OVERALL CONDITION												
METAL		S.G.

① CLEAN/REPAINT

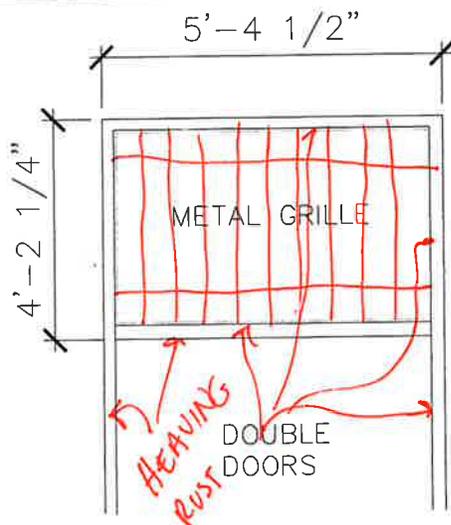
WINDOW				SPECIFIC CONDITION NOTES																			
WINDOW NO.	EXPOSURE	TYPE		EXTERIOR FINISH	INTERIOR FINISH	GLASS	FRAME	SASHES	HARDWARE	GLAZING MATERIAL	WEATHERSTRIPPING	SUPPORT MATERIAL	SILL	PERIMETER SEALANT									
G-222-W		G		Poor	Poor	Good	Poor	N/A		BAD	BAD	FAIR	Poor	BAD									
SCALE: 1/4" = 1'-0"				WINDOW SURVEY/WINDOW TYPES																			
DATE:		JOB NO.: 2023.113		VAN ZANDT COUNTY COURTHOUSE																			
				121 E. DALLAS STREET CANTON, TEXAS 75103																			
				TYPE G																			
				Sheet ___ of ___

① CLEAN/REPAINT

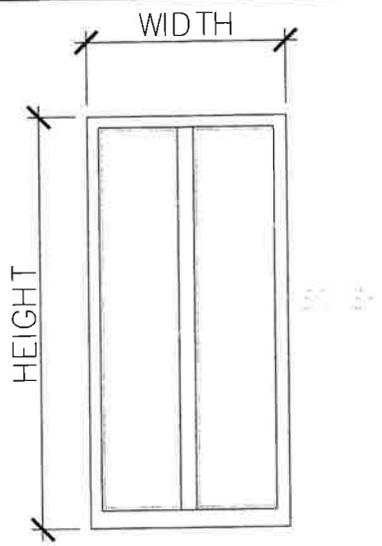
WINDOW				SPECIFIC CONDITION NOTES													
WINDOW NO.	EXPOSURE	TYPE	OVERALL CONDITION	EXTERIOR FINISH	INTERIOR FINISH	GLASS	FRAME	SASHES	HARDWARE	GLAZING MATERIAL	WEATHERSTRIPPING	SUPPORT MATERIAL	SILL	PERIMETER SEALANT			
E-223-W		E	Good	Good		Good	Good	N/A		BAD	BAD	Good	Good	BAD

① CLEAN/REPAINT

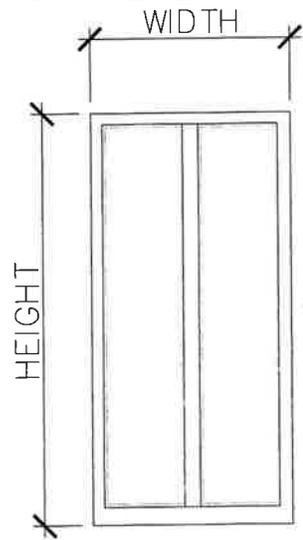
WINDOW						SPECIFIC CONDITION NOTES															
WINDOW NO.	EXPOSURE	TYPE	FRAME MATERIAL	GLAZING MATERIAL	OVERALL CONDITION	EXTERIOR FINISH	INTERIOR FINISH	GLASS	FRAME	SASHES	HARDWARE	GLAZING MATERIAL	WEATHERSTRIPPING	SUPPORT MATERIAL	SILL	PERIMETER SEALANT					
E-224-W		E	METAL	S.G.	Good	Good		Good	Good	N/A		BAD	BAD	Good	Good	BAD					
SCALE: 1/4" = 1'-0"						WINDOW SURVEY/WINDOW TYPES										TYPE E Sheet ___ of ___					
DATE:			JOB NO.: 2023.113			VAN ZANDT COUNTY COURTHOUSE															
						121 E. DALLAS STREET CANTON, TEXAS 75103

① CLEAN/REPAINT

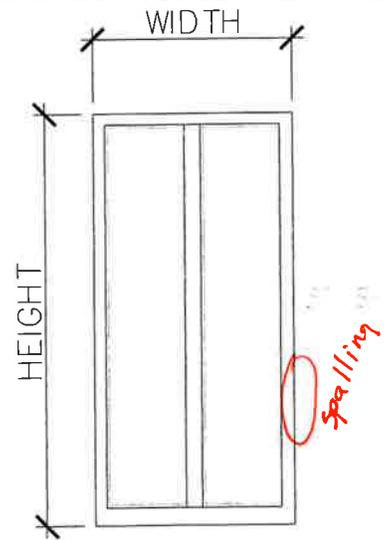
WINDOW		SPECIFIC CONDITION NOTES																		
WINDOW NO. 225	EXPOSURE	TYPE E	FRAME MATERIAL	GLAZING MATERIAL	OVERALL CONDITION	EXTERIOR FINISH	INTERIOR FINISH	GLASS	FRAME	SASHES	HARDWARE	GLAZING MATERIAL	WEATHERSTRIPPING	SUPPORT MATERIAL <i>Spalling @ lower right</i>	SILL	PERIMETER SEALANT				
E-225-W			METAL	S.G.	<i>Good</i>	<i>Good</i>		<i>Good</i>	<i>Good</i>	<i>N/A</i>		<i>BAD</i>	<i>BAD</i>	<i>Good / Fair</i>	<i>Good</i>	<i>BAD</i>				
SCALE: 1/4" = 1'-0"		WINDOW SURVEY/WINDOW TYPES												<p>TYPE E</p> <p>Sheet ___ of ___</p>						
DATE:	JOB NO.: 2023.113	<p>VAN ZANDT COUNTY COURTHOUSE</p> <p>121 E. DALLAS STREET CANTON, TEXAS 75103</p>

① CLEAN/REPAINT

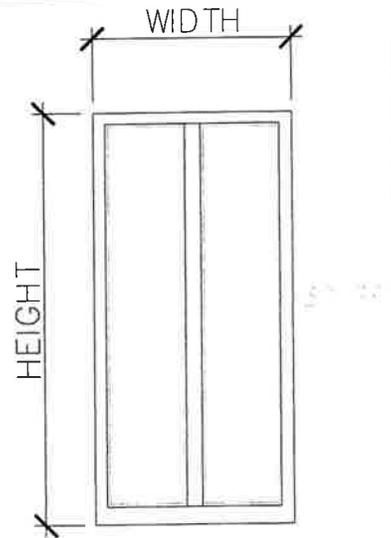
WINDOW				SPECIFIC CONDITION NOTES																						
WINDOW NO. 227	EXPOSURE	TYPE	E	EXTERIOR FINISH	INTERIOR FINISH	GLASS	FRAME	SASHES	HARDWARE	GLAZING MATERIAL	WEATHERSTRIPPING	SUPPORT MATERIAL	SILL	PERIMETER SEALANT												
E-227-S				<i>Poor</i>	<i>Poor</i>	<i>Good</i>	<i>Poor</i>	<i>N/A</i>		<i>BAD</i>	<i>BAD</i>	<i>Good</i>	<i>Poor</i>	<i>BAD</i>												
SCALE: 1/4" = 1'-0"				WINDOW SURVEY/WINDOW TYPES												TYPE E										
DATE:		JOB NO.: 2023.113		VAN ZANDT COUNTY COURTHOUSE

① CLEAN/REPAINT

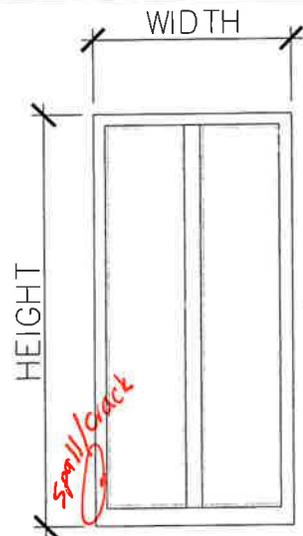
WINDOW		SPECIFIC CONDITION NOTES																				
WINDOW NO. 228	E																					
EXPOSURE	TYPE	FRAME MATERIAL	GLAZING MATERIAL	OVERALL CONDITION	EXTERIOR FINISH	INTERIOR FINISH	GLASS	FRAME	SASHES	HARDWARE	GLAZING MATERIAL	WEATHERSTRIPPING	SUPPORT MATERIAL	SILL	PERIMETER SEALANT							
E-228-S		METAL	S.G.	<i>Good</i>	<i>Good</i>		<i>Good</i>	<i>Good</i>	<i>N/A</i>		<i>BAD</i>	<i>BAD</i>	<i>Good - small crack @ left bottom</i>	<i>Good</i>	<i>BAD</i>							
SCALE: 1/4" = 1'-0"		WINDOW SURVEY/WINDOW TYPES												TYPE E								
DATE:	JOB NO.: 2023.113	VAN ZANDT COUNTY COURTHOUSE																				
		121 E. DALLAS STREET CANTON, TEXAS 75103												Sheet ___ of ___

① CLEAN/REPAINT

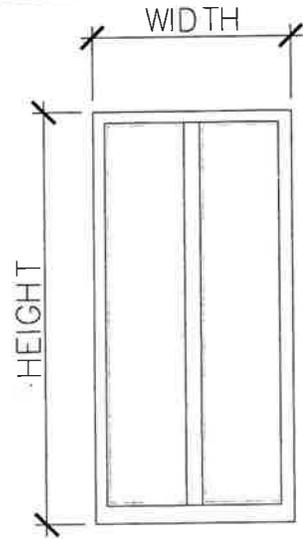
WINDOW		SPECIFIC CONDITION NOTES																				
WINDOW NO. 230	EXPOSURE	TYPE	FRAME MATERIAL	GLAZING MATERIAL	OVERALL CONDITION	EXTERIOR FINISH	INTERIOR FINISH	GLASS	FRAME	SASHES	HARDWARE	GLAZING MATERIAL	WEATHERSTRIPPING	SUPPORT MATERIAL	SILL	PERIMETER SEALANT						
E-230-S		E	METAL	S.G.	Good	Good		Good	Good	N/A		BAD	BAD	Good	Good	BAD						
SCALE: 1/4" = 1'-0"						WINDOW SURVEY/WINDOW TYPES						<p>TYPE E</p> <p>Sheet__of__</p>										
DATE:		JOB NO.: 2023.113				<p>VAN ZANDT COUNTY COURTHOUSE</p> <p>121 E. DALLAS STREET CANTON, TEXAS 75103</p>

① CLEAN/REPAINT

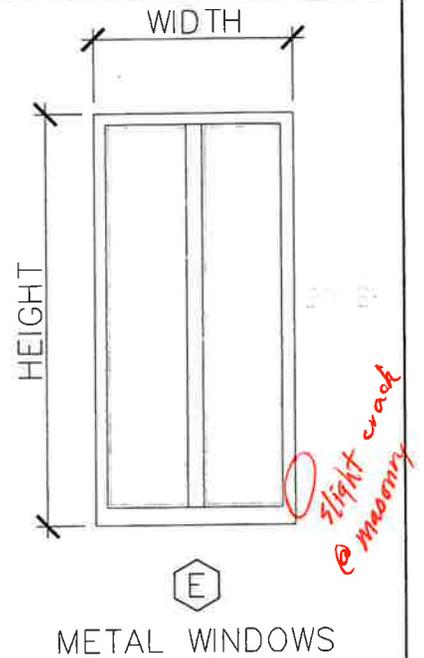
WINDOW		SPECIFIC CONDITION NOTES																		
WINDOW NO. 231	EXPOSURE	TYPE	E																	
E-231-S		METAL	S.G.	FAIR	FAIR	GOOD	FAIR	N/A	BAD	BAD	Good	FAIR	BAD							
SCALE: 1/4" = 1'-0"		WINDOW SURVEY/WINDOW TYPES										TYPE E								
DATE:	JOB NO.: 2023.113	VAN ZANDT COUNTY COURTHOUSE										Sheet ___ of ___								
KOMATSU ARCHITECTURE		121 E. DALLAS STREET CANTON, TEXAS 75103

① CLEAN/REPAINT

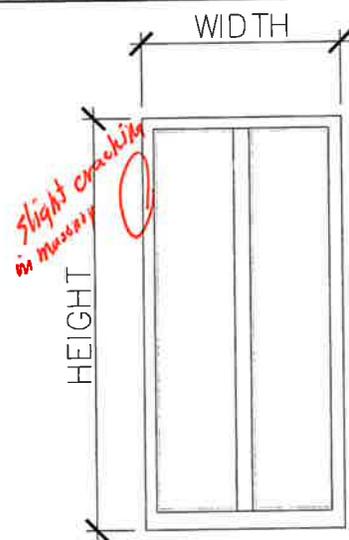
WINDOW				SPECIFIC CONDITION NOTES														
WINDOW NO. 232	EXPOSURE	TYPE E		EXTERIOR FINISH	INTERIOR FINISH	GLASS	FRAME	SASHES	HARDWARE	GLAZING MATERIAL	WEATHERSTRIPPING	SUPPORT MATERIAL	SILL	PERIMETER SEALANT				
E-232-S			METAL	S.G.	FAIR	FAIR	GOOD	FAIR	N/A	BAD	BAD	Good	FAIR	BAD				
SCALE: 1/4" = 1'-0"			WINDOW SURVEY/WINDOW TYPES															
DATE:			JOB NO.: 2023.113			VAN ZANDT COUNTY COURTHOUSE						TYPE E						
			121 E. DALLAS STREET CANTON, TEXAS 75103			Sheet ___ of ___

Slight cracking in masonry top left

① CLEAN/REPAINT

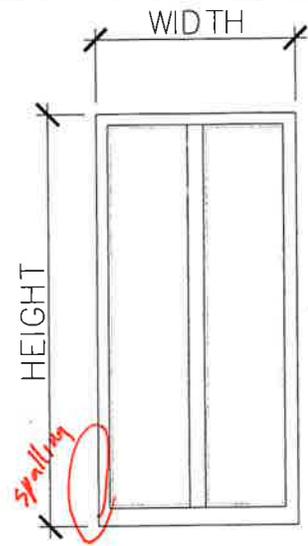
WINDOW		SPECIFIC CONDITION NOTES																				
WINDOW NO. 233	EXPOSURE	TYPE E	FRAME MATERIAL	GLAZING MATERIAL	OVERALL CONDITION	EXTERIOR FINISH	INTERIOR FINISH	GLASS	FRAME	SASHES	HARDWARE	GLAZING MATERIAL	WEATHERSTRIPPING	SUPPORT MATERIAL <i>Spalling bottom left</i>	SILL	PERIMETER SEALANT						
E-233-S			METAL	S.G.	FAIR	FAIR		Good	FAIR	N/A		BAD	BAD	Good	FAIR	BAD						
SCALE: 1/4" = 1'-0"		WINDOW SURVEY/WINDOW TYPES												TYPE E								
DATE:	JOB NO.: 2023.113	VAN ZANDT COUNTY COURTHOUSE																				
		121 E. DALLAS STREET CANTON, TEXAS 75103												Sheet ___ of ___

① CLEAN/REPAINT

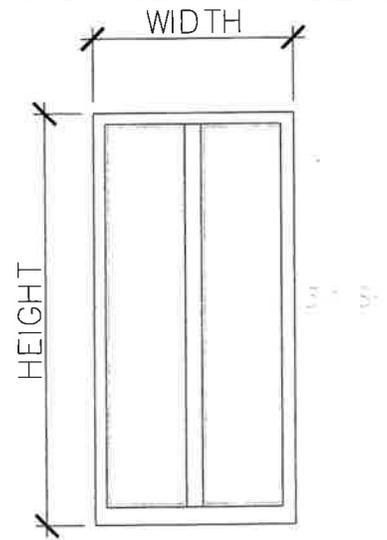
WINDOW			SPECIFIC CONDITION NOTES													
WINDOW NO. 234	EXPOSURE	TYPE E	EXTERIOR FINISH	INTERIOR FINISH	GLASS	FRAME	SASHES	HARDWARE	GLAZING MATERIAL	WEATHERSTRIPPING	SUPPORT MATERIAL	SILL	PERIMETER SEALANT			
E-234-S			POOR		GOOD	FAIR	N/A		BAD	BAD	GOOD	FAIR	BAD			
SCALE: 1/4" = 1'-0"			WINDOW SURVEY/WINDOW TYPES													
DATE:		JOB NO.: 2023.113	VAN ZANDT COUNTY COURTHOUSE													
			121 E. DALLAS STREET CANTON, TEXAS 75103													
													TYPE E			
													Sheet ___ of ___

① CLEAN/REPAINT

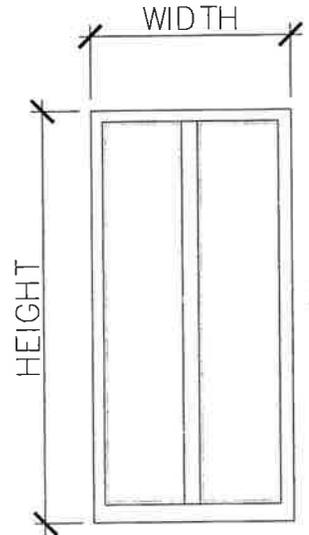
WINDOW				SPECIFIC CONDITION NOTES																				
E-235-S	WINDOW NO. 235	EXPOSURE	TYPE E	FRAME MATERIAL	GLAZING MATERIAL	OVERALL CONDITION	EXTERIOR FINISH	INTERIOR FINISH	GLASS	FRAME	SASHES	HARDWARE	GLAZING MATERIAL	WEATHERSTRIPPING	SUPPORT MATERIAL	SILL	PERIMETER SEALANT							
				METAL	S.G.	FAIR	FAIR		Good	FAIR	N/A		BAD	BAD	Good	FAIR	BAD							
SCALE: 1/4" = 1'-0"				WINDOW SURVEY/WINDOW TYPES																				
DATE:		JOB NO.: 2023.113		VAN ZANDT COUNTY COURTHOUSE																				
				121 E. DALLAS STREET CANTON, TEXAS 75103																				
																TYPE E								
																Sheet ___ of ___

① CLEAN/REPAINT

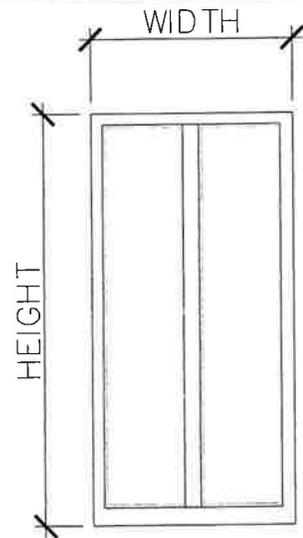
WINDOW						SPECIFIC CONDITION NOTES															
WINDOW NO.	EXPOSURE	TYPE	FRAME MATERIAL	GLAZING MATERIAL	OVERALL CONDITION	EXTERIOR FINISH	INTERIOR FINISH	GLASS	FRAME	SASHES	HARDWARE	GLAZING MATERIAL	WEATHERSTRIPPING	SUPPORT MATERIAL	SILL	PERIMETER SEALANT					
E-236-S		E	METAL	S.G.	FAIR	FAIR		Good	FAIR	N/A		BAD	BAD	Good	FAIR	BAD					
SCALE: 1/4" = 1'-0"						WINDOW SURVEY/WINDOW TYPES															
DATE:			JOB NO.: 2023.113			VAN ZANDT COUNTY COURTHOUSE															
						121 E. DALLAS STREET CANTON, TEXAS 75103						TYPE E									
												Sheet ___ of ___

① CLEAN/REPAINT

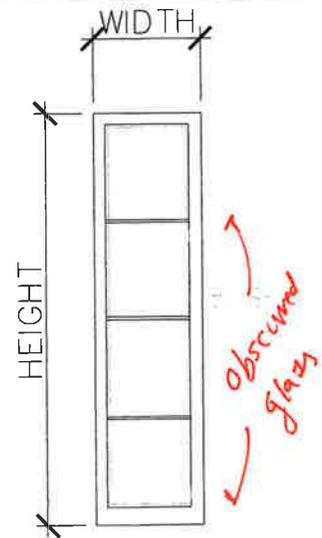
WINDOW						SPECIFIC CONDITION NOTES															
WINDOW NO.	EXPOSURE	TYPE	FRAME MATERIAL	GLAZING MATERIAL	OVERALL CONDITION	EXTERIOR FINISH	INTERIOR FINISH	GLASS	FRAME	SASHES	HARDWARE	GLAZING MATERIAL	WEATHERSTRIPPING	SUPPORT MATERIAL	SILL	PERIMETER SEALANT					
J-237-S		J	METAL	S.G.	Good	Good		Obscured - All	Good	Good	N/A		Fair	Fair	Good	Good	Fair				
SCALE: 1/4" = 1'-0"						WINDOW SURVEY/WINDOW TYPES															
DATE:			JOB NO.: 2023.113			VAN ZANDT COUNTY COURTHOUSE															
						121 E. DALLAS STREET CANTON, TEXAS 75103															
																	TYPE J				
																	Sheet ___ of ___

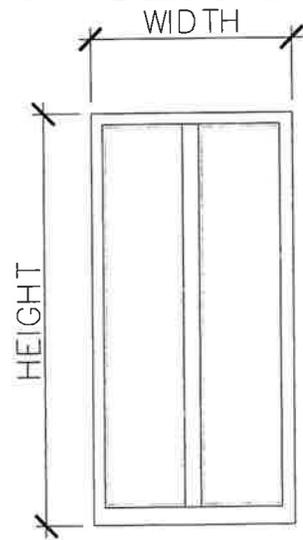
WINDOW					SPECIFIC CONDITION NOTES														
WINDOW NO.	EXPOSURE	TYPE	FRAME MATERIAL	GLAZING MATERIAL	OVERALL CONDITION	EXTERIOR FINISH	INTERIOR FINISH	GLASS	FRAME	SASHES	HARDWARE	GLAZING MATERIAL	WEATHERSTRIPPING	SUPPORT MATERIAL	SILL	PERIMETER SEALANT			
E-238-S		E	METAL	S.G.	FAIR	FAIR		GOOD	GOOD	N/A		BAD	BAD	GOOD	FAIR	BAD			
SCALE: 1/4" = 1'-0"					WINDOW SURVEY/WINDOW TYPES														
DATE:		JOB NO.: 2023.113			VAN ZANDT COUNTY COURTHOUSE												TYPE E		
					121 E. DALLAS STREET CANTON, TEXAS 75103														
																	Sheet ___ of ___

① CLEAN/REPAINT

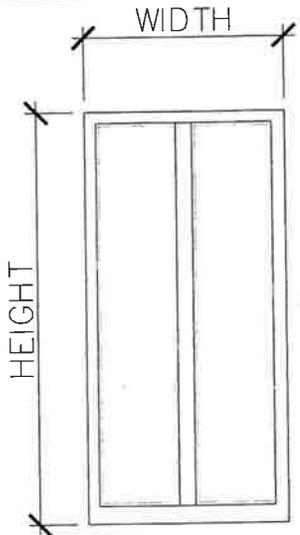
WINDOW		SPECIFIC CONDITION NOTES																					
WINDOW NO. 239																							
EXPOSURE	E																						
TYPE	E																						
FRAME MATERIAL		METAL																					
GLAZING MATERIAL		S.G.																					
OVERALL CONDITION		FAIR																					
EXTERIOR FINISH		Good																					
INTERIOR FINISH																							
GLASS		Good																					
FRAME		Good																					
SASHES		N/A																					
HARDWARE																							
GLAZING MATERIAL		BAD																					
WEATHERSTRIPPING		BAD																					
SUPPORT MATERIAL		Good																					
SILL		FAIR																					
PERIMETER SEALANT		BAD																					
SCALE: 1/4" = 1'-0"		WINDOW SURVEY/WINDOW TYPES												TYPE E									
DATE:	JOB NO.: 2023.113	VAN ZANDT COUNTY COURTHOUSE																					
		121 E. DALLAS STREET CANTON, TEXAS 75103												Sheet ___ of ___

① CLEAN/REPAINT

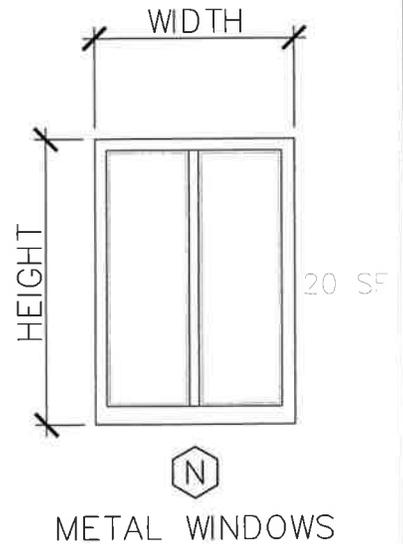
WINDOW				SPECIFIC CONDITION NOTES																				
WINDOW NO. 301	EXPOSURE	TYPE	N																					
N-301-E				METAL	S.G.	FAIR		FAIR		GOOD	FAIR	N/A		BAD	BAD	GOOD	FAIR	BAD						
SCALE: 1/4" = 1'-0"				WINDOW SURVEY/WINDOW TYPES																				
DATE:		JOB NO.: 2023.113		VAN ZANDT COUNTY COURTHOUSE																				
KOMATSU ARCHITECTURE				121 E. DALLAS STREET CANTON, TEXAS 75103																				
				TYPE N																				
				Sheet ___ of ___

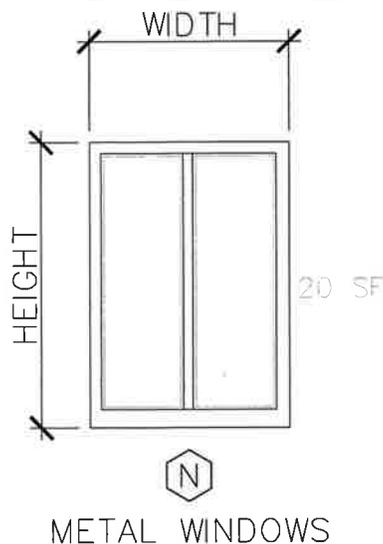
WINDOW				SPECIFIC CONDITION NOTES																			
302		N																					
WINDOW NO.	EXPOSURE	TYPE	FRAME MATERIAL	GLAZING MATERIAL	OVERALL CONDITION	EXTERIOR FINISH	INTERIOR FINISH	GLASS	FRAME	SASHES	HARDWARE	GLAZING MATERIAL	WEATHERSTRIPPING	SUPPORT MATERIAL	SILL	PERIMETER SEALANT							
N-302-E			METAL	S.G.	FAIR	FAIR		GOOD	FAIR	N/A		BAD	BAD	GOOD	FAIR	BAD							
SCALE: 1/4" = 1'-0"				WINDOW SURVEY/WINDOW TYPES												TYPE N							
DATE:		JOB NO.: 2023.113		VAN ZANDT COUNTY COURTHOUSE																			
				121 E. DALLAS STREET CANTON, TEXAS 75103																			
																Sheet ___ of ___

① CLEAN/REPAINT

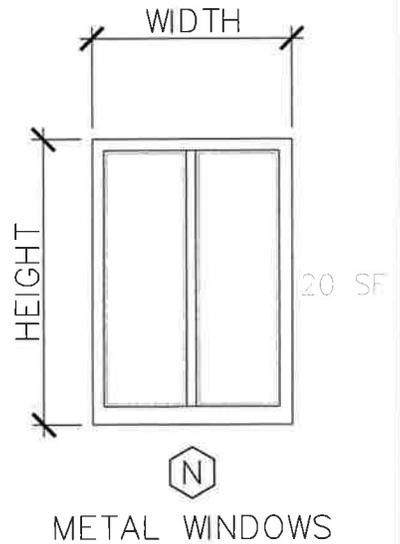
WINDOW				SPECIFIC CONDITION NOTES																			
WINDOW NO. 303	EXPOSURE	TYPE	N	EXTERIOR FINISH	INTERIOR FINISH	GLASS	FRAME	SASHES	HARDWARE	GLAZING MATERIAL	WEATHERSTRIPPING	SUPPORT MATERIAL	SILL	PERIMETER SEALANT									
N-303-E				FAIR	FAIR	GOOD	FAIR	N/A		BAD	BAD	GOOD	FAIR	BAD									
SCALE: 1/4" = 1'-0"				WINDOW SURVEY/WINDOW TYPES																			
DATE:		JOB NO.: 2023.113		VAN ZANDT COUNTY COURTHOUSE										TYPE N									
KOMATSU ARCHITECTURE				121 E. DALLAS STREET CANTON, TEXAS 75103										Sheet ___ of ___

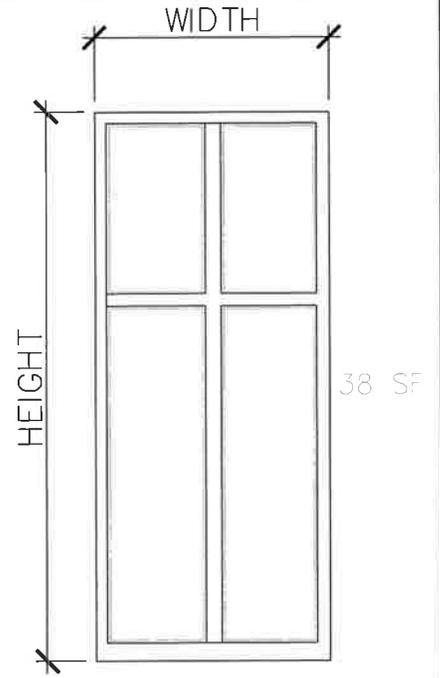
WINDOW				SPECIFIC CONDITION NOTES															
WINDOW NO. 304	EXPOSURE	TYPE	P	EXTERIOR FINISH	INTERIOR FINISH	GLASS	FRAME	SASHES	HARDWARE	GLAZING MATERIAL	WEATHERSTRIPPING	SUPPORT MATERIAL	SILL	PERIMETER SEALANT					
P-304-E				METAL	S.G.	FAIR	FAIR	GOOD	FAIR	N/A	BAD	BAD	GOOD	FAIR	BAD				
SCALE: 1/4" = 1'-0"				WINDOW SURVEY/WINDOW TYPES															
DATE:		JOB NO.: 2023.113		VAN ZANDT COUNTY COURTHOUSE															
				121 E. DALLAS STREET CANTON, TEXAS 75103															
				TYPE P Sheet__of__

① CLEAN/REPAINT

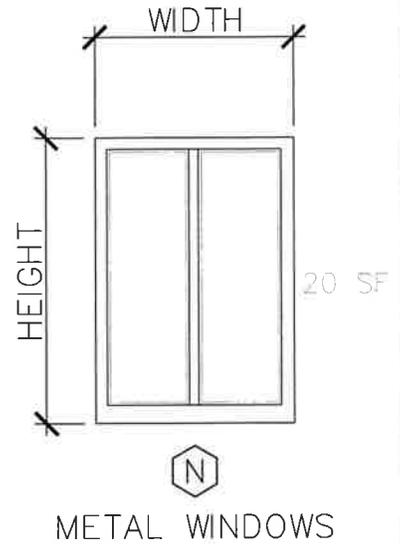
WINDOW				SPECIFIC CONDITION NOTES														
WINDOW NO. 306	EXPOSURE	TYPE N		EXTERIOR FINISH	INTERIOR FINISH	GLASS	FRAME	SASHES	HARDWARE	GLAZING MATERIAL	WEATHERSTRIPPING	SUPPORT MATERIAL	SILL	PERIMETER SEALANT				
N-306-E			METAL	S.G.	FAIR	FAIR	GOOD	FAIR	N/A		BAD	BAD	GOOD	FAIR	BAD			
SCALE: 1/4" = 1'-0"				WINDOW SURVEY/WINDOW TYPES														
DATE:		JOB NO.: 2023.113		VAN ZANDT COUNTY COURTHOUSE														
KOMATSU ARCHITECTURE				121 E. DALLAS STREET CANTON, TEXAS 75103														
				TYPE N														
				Sheet ___ of ___

① CLEAN/REPAINT

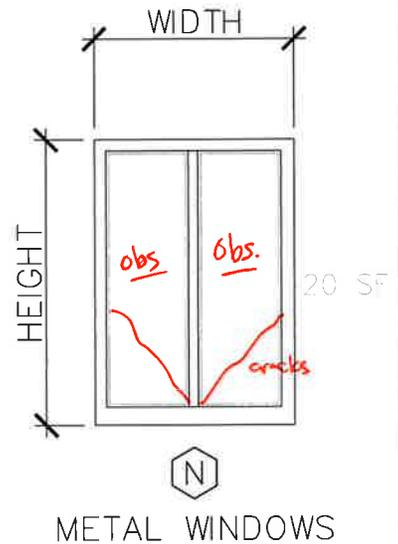
WINDOW					SPECIFIC CONDITION NOTES															
WINDOW NO.	EXPOSURE	TYPE	FRAME MATERIAL	GLAZING MATERIAL	OVERALL CONDITION	EXTERIOR FINISH	INTERIOR FINISH	GLASS	FRAME	SASHES	HARDWARE	GLAZING MATERIAL	WEATHERSTRIPPING	SUPPORT MATERIAL	SILL	PERIMETER SEALANT				
N-307-E		N	METAL	S.G.	FAIR	FAIR		Repl.	BAD	FAIR	N/A		BAD	BAD	GOOD	FAIR	BAD			
SCALE: 1/4" = 1'-0"						WINDOW SURVEY/WINDOW TYPES										TYPE N				
DATE:		JOB NO.: 2023.113				VAN ZANDT COUNTY COURTHOUSE														
						121 E. DALLAS STREET CANTON, TEXAS 75103										Sheet ___ of ___

① CLEAN/REPAINT
