VAN ZANDT COUNTY COURTHOUSE
 121 E. DALLAS ST.
 CANTON, TX 75103

DATE	06/04/2020
PROJECT NO.	1608818045
SHEET NO.	A2.001
1ST FLOOR EXISTING & DEMOLITION

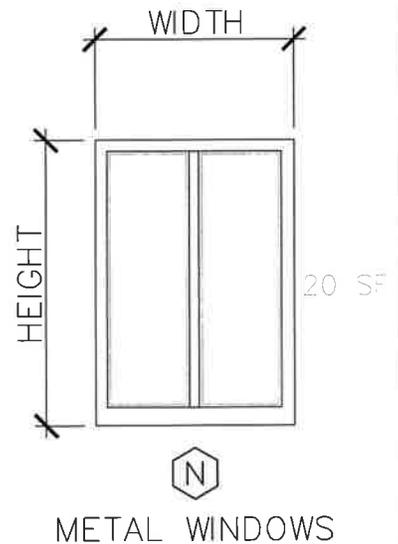
WINDOW					SPECIFIC CONDITION NOTES														
WINDOW NO.	EXPOSURE	TYPE	FRAME MATERIAL	GLAZING MATERIAL	OVERALL CONDITION	EXTERIOR FINISH	INTERIOR FINISH	GLASS	FRAME	SASHES	HARDWARE	GLAZING MATERIAL	WEATHERSTRIPPING	SUPPORT MATERIAL	SILL	PERIMETER SEALANT			
N-308-E		N	METAL	S.G.	FAIR	FAIR		GOOD	FAIR	N/A		BAD	BAD	GOOD	FAIR	BAD			
SCALE: 1/4" = 1'-0"					WINDOW SURVEY/WINDOW TYPES														
DATE:		JOB NO.: 2023.113			VAN ZANDT COUNTY COURTHOUSE														
					121 E. DALLAS STREET CANTON, TEXAS 75103														
TYPE N																			
Sheet ___ of ___

① CLEAN/REPAINT

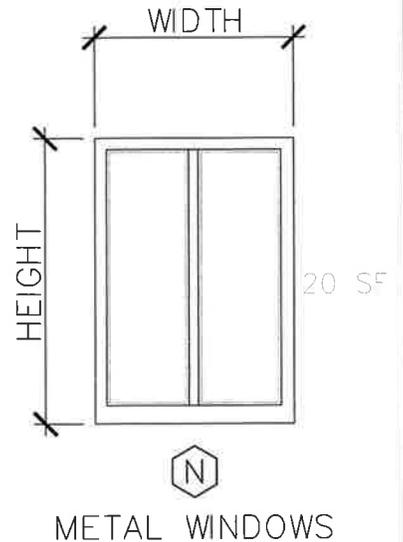
WINDOW					SPECIFIC CONDITION NOTES															
WINDOW NO. 309	EXPOSURE	TYPE	FRAME MATERIAL	GLAZING MATERIAL	OVERALL CONDITION	EXTERIOR FINISH	INTERIOR FINISH	GLASS	FRAME	SASHES	HARDWARE	GLAZING MATERIAL	WEATHERSTRIPPING	SUPPORT MATERIAL	SILL	PERIMETER SEALANT				
N-309-N		N	METAL	S.G.	FAIR	FAIR		GOOD	FAIR	N/A		BAD	BAD	GOOD	FAIR	BAD				
SCALE: 1/4" = 1'-0"					WINDOW SURVEY/WINDOW TYPES															
DATE:		JOB NO.: 2023.113			VAN ZANDT COUNTY COURTHOUSE										TYPE N					
KOMATSU ARCHITECTURE					121 E. DALLAS STREET CANTON, TEXAS 75103										Sheet ___ of ___

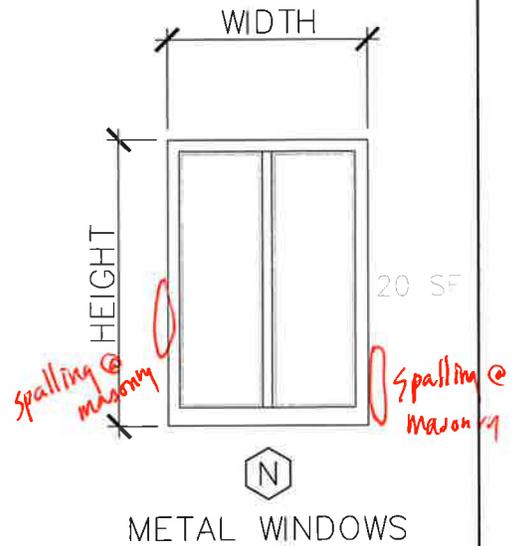
WINDOW				SPECIFIC CONDITION NOTES														
WINDOW NO. 310	EXPOSURE	TYPE	N	EXTERIOR FINISH	INTERIOR FINISH	GLASS	FRAME	SASHES	HARDWARE	GLAZING MATERIAL	WEATHERSTRIPPING	SUPPORT MATERIAL	SILL	PERIMETER SEALANT				
N-310-N				FAIR		GOOD	FAIR	N/A		BAD	BAD	POOR	FAIR	BAD				
SCALE: 1/4" = 1'-0"				WINDOW SURVEY/WINDOW TYPES														
DATE:		JOB NO.: 2023.113		VAN ZANDT COUNTY COURTHOUSE										TYPE N				
KOMATSU ARCHITECTURE				121 E. DALLAS STREET CANTON, TEXAS 75103										Sheet ___ of ___

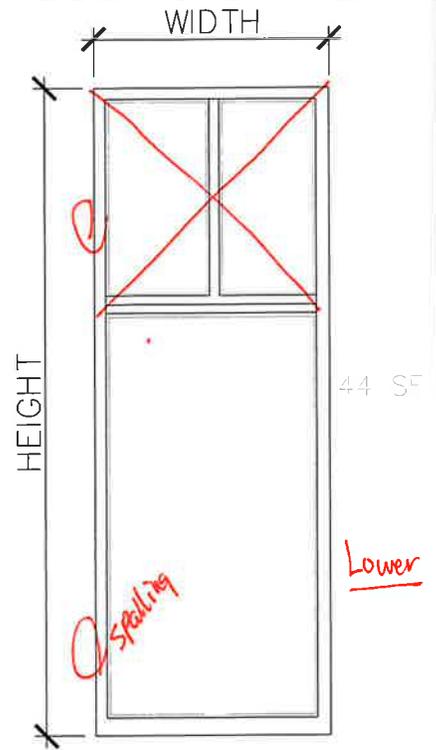
WINDOW						SPECIFIC CONDITION NOTES																	
WINDOW NO.	EXPOSURE	TYPE	FRAME MATERIAL	GLAZING MATERIAL	OVERALL CONDITION	EXTERIOR FINISH	INTERIOR FINISH	GLASS	FRAME	SASHES	HARDWARE	GLAZING MATERIAL	WEATHERSTRIPPING	SUPPORT MATERIAL	SILL	PERIMETER SEALANT							
Q-311-N		Q	METAL	S.G.	FAIR	FAIR		GOOD	FAIR	N/A		BAD	BAD	FAIR	FAIR	BAD

1) CLEAN/REPAINT

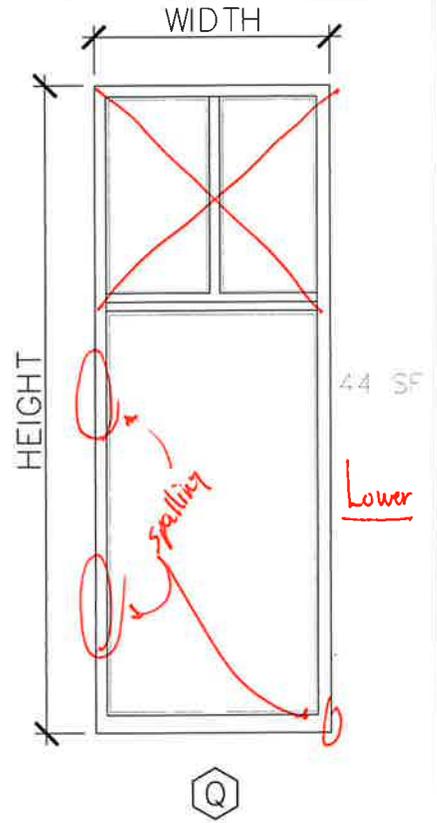
WINDOW				SPECIFIC CONDITION NOTES																			
WINDOW NO. 312	EXPOSURE	TYPE	Q	EXTERIOR FINISH	INTERIOR FINISH	GLASS	FRAME	SASHES	HARDWARE	GLAZING MATERIAL	WEATHERSTRIPPING	SUPPORT MATERIAL	SILL	PERIMETER SEALANT									
Q-312-N				FAIR	FAIR	GOOD	FAIR	N/A		BAD	BAD	FAIR	FAIR	BAD									
SCALE: 1/4" = 1'-0"				WINDOW SURVEY/WINDOW TYPES																			
DATE:		JOB NO.: 2023.113		VAN ZANDT COUNTY COURTHOUSE																			
KOMATSU ARCHITECTURE				121 E. DALLAS STREET CANTON, TEXAS 75103																			
														TYPE Q									
														Sheet ___ of ___

CLEAN/REPAINT

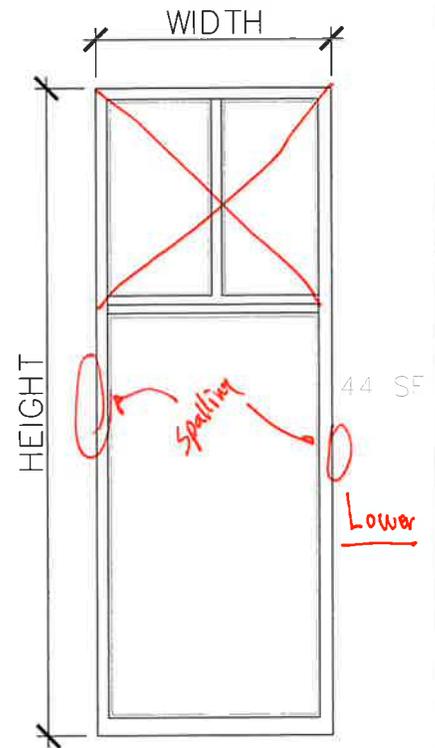
WINDOW					SPECIFIC CONDITION NOTES															
WINDOW NO.	EXPOSURE	TYPE	FRAME MATERIAL	GLAZING MATERIAL	OVERALL CONDITION	EXTERIOR FINISH	INTERIOR FINISH	GLASS	FRAME	SASHES	HARDWARE	GLAZING MATERIAL	WEATHERSTRIPPING	SUPPORT MATERIAL	SILL	PERIMETER SEALANT				
Q-313-N			METAL	S.G.	FAIR	FAIR		GOOD	FAIR	N/A		BAD	BAD	FAIR	FAIR	BAD

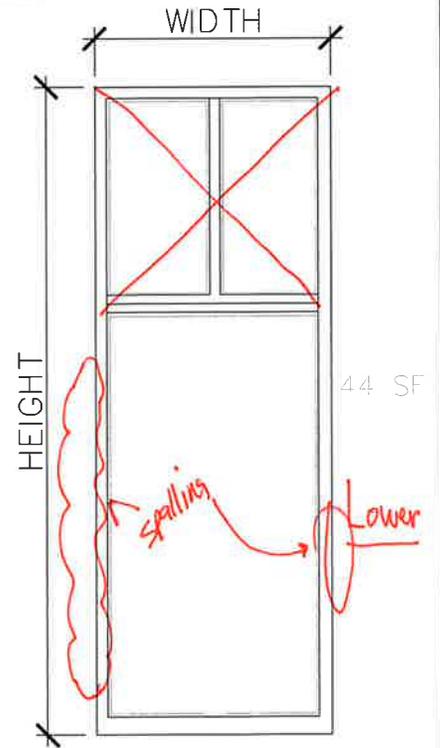
WINDOW						SPECIFIC CONDITION NOTES														
WINDOW NO.	EXPOSURE	TYPE	FRAME MATERIAL	GLAZING MATERIAL	OVERALL CONDITION	EXTERIOR FINISH	INTERIOR FINISH	GLASS	FRAME	SASHES	HARDWARE	GLAZING MATERIAL	WEATHERSTRIPPING	SUPPORT MATERIAL	SILL	PERIMETER SEALANT				
Q-314-N		Q	METAL	S.G.	<i>Poor</i>	<i>Poor</i>		<i>Good</i>	<i>Poor-Fair</i>	<i>N/A</i>		<i>BAD</i>	<i>PAD</i>	<i>FAIR</i>	<i>FAIR</i>	<i>BAD</i>				
SCALE: 1/4" = 1'-0"						WINDOW SURVEY/WINDOW TYPES										TYPE Q				
DATE:		JOB NO.: 2023.113				VAN ZANDT COUNTY COURTHOUSE														
						121 E. DALLAS STREET CANTON, TEXAS 75103										Sheet ___ of ___

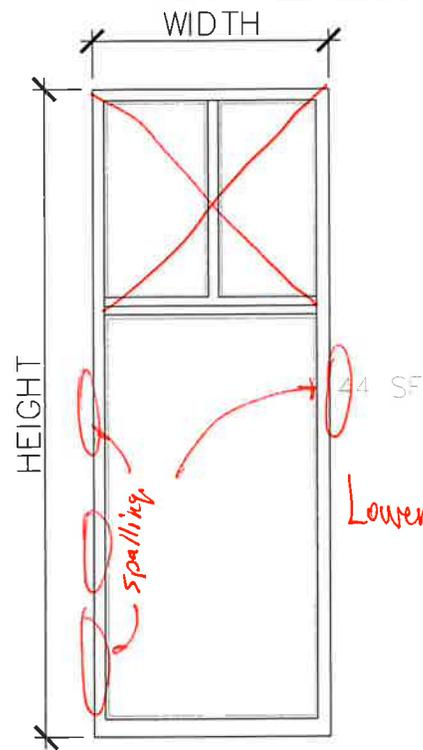
WINDOW						SPECIFIC CONDITION NOTES																	
315	EXPOSURE	TYPE	Q	FRAME MATERIAL	GLAZING MATERIAL	OVERALL CONDITION	EXTERIOR FINISH	INTERIOR FINISH	GLASS	FRAME	SASHES	HARDWARE	GLAZING MATERIAL	WEATHERSTRIPPING	SUPPORT MATERIAL	SILL	PERIMETER SEALANT						
Q-315-N				METAL	S.G.	Poor	Poor		Good	Poor	N/A		BAD	BAD	FAIR	FAIR/POOR	BAD						
SCALE: 1/4" = 1'-0"						WINDOW SURVEY/WINDOW TYPES																	
DATE:		JOB NO.: 2023.113				VAN ZANDT COUNTY COURTHOUSE												TYPE Q					
KOMATSU ARCHITECTURE						121 E. DALLAS STREET CANTON, TEXAS 75103												Sheet ___ of ___

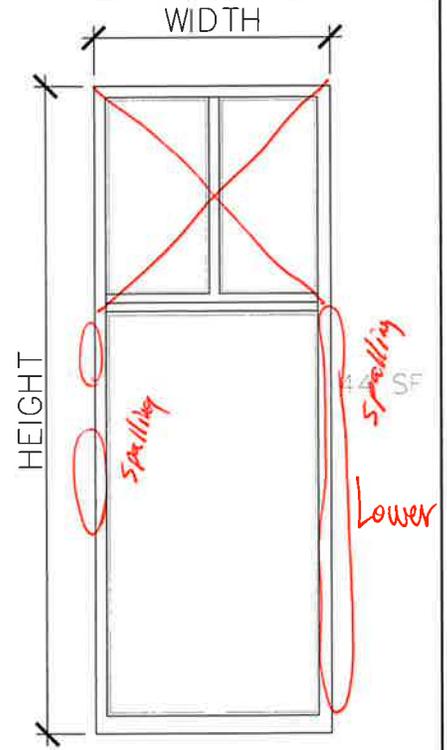
WINDOW				SPECIFIC CONDITION NOTES														
316	EXPOSURE	TYPE	Q	EXTERIOR FINISH	INTERIOR FINISH	GLASS	FRAME	SASHES	HARDWARE	GLAZING MATERIAL	WEATHERSTRIPPING	SUPPORT MATERIAL	SILL	PERIMETER SEALANT				
Q-316-N				Poor		Good	Poor	N/A		BAD	BAD	FAIR	Poor	BAD				
SCALE: 1/4" = 1'-0"				WINDOW SURVEY/WINDOW TYPES														
DATE:		JOB NO.: 2023.113		VAN ZANDT COUNTY COURTHOUSE										TYPE Q				
KOMATSU ARCHITECTURE		121 E. DALLAS STREET CANTON, TEXAS 75103										Sheet ___ of ___

1) CLEAN/REPAINT

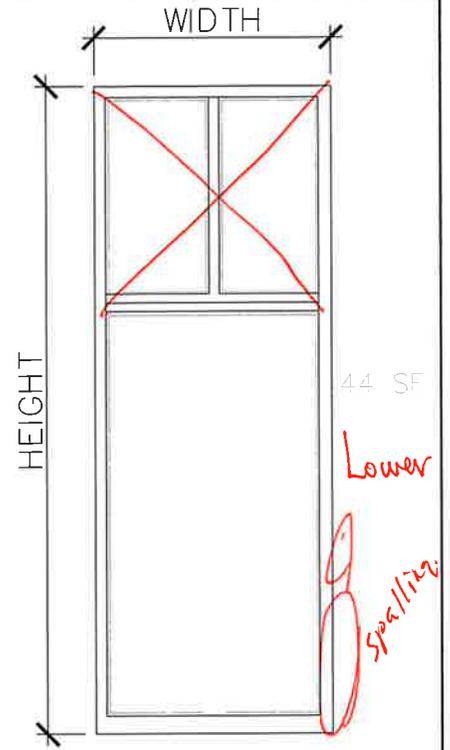
WINDOW					SPECIFIC CONDITION NOTES																		
WINDOW NO. 317	EXPOSURE	TYPE Q	FRAME MATERIAL	GLAZING MATERIAL	OVERALL CONDITION	EXTERIOR FINISH	INTERIOR FINISH	GLASS	FRAME	SASHES	HARDWARE	GLAZING MATERIAL	WEATHERSTRIPPING	SUPPORT MATERIAL	SILL	PERIMETER SEALANT							
Q-317-N			METAL	S.G.	Poor	Poor		Good	Poor	N/A		Bad	Bad	FAIR	Poor	Bad							
SCALE: 1/4" = 1'-0"						WINDOW SURVEY/WINDOW TYPES						<p>TYPE Q</p> <p>Sheet ___ of ___</p>											
DATE:			JOB NO.: 2023.113			VAN ZANDT COUNTY COURTHOUSE																	
						121 E. DALLAS STREET CANTON, TEXAS 75103

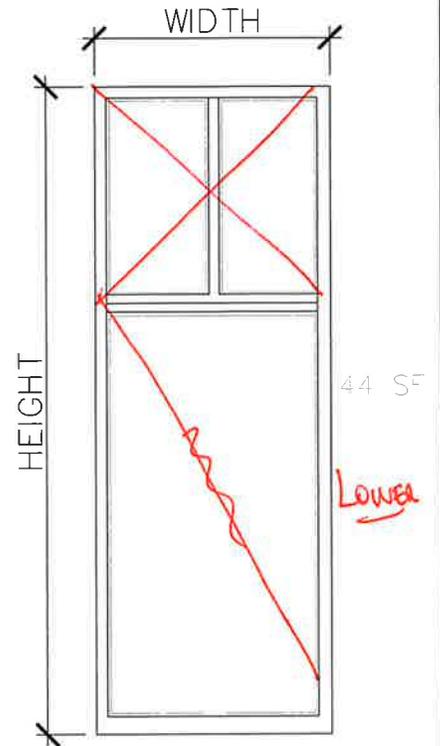
WINDOW					SPECIFIC CONDITION NOTES														
WINDOW NO.	EXPOSURE	TYPE	FRAME MATERIAL	GLAZING MATERIAL	OVERALL CONDITION	EXTERIOR FINISH	INTERIOR FINISH	GLASS	FRAME	SASHES	HARDWARE	GLAZING MATERIAL	WEATHERSTRIPPING	SUPPORT MATERIAL	SILL	PERIMETER SEALANT			
319		Q																	
Q-319-N			METAL	S.G.	Poor	Poor		Good	Poor	N/A		BAD	BAD	Good	Poor	BAD

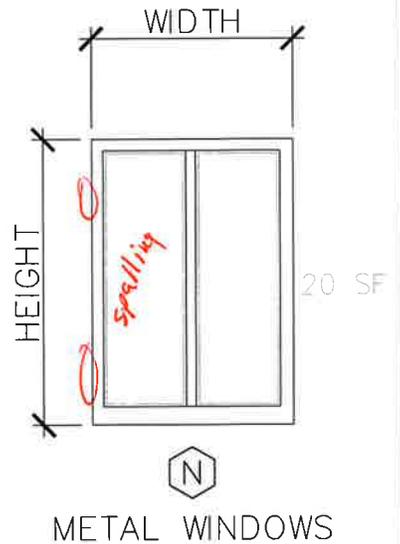
WINDOW					SPECIFIC CONDITION NOTES																	
WINDOW NO. 320	EXPOSURE	TYPE	FRAME MATERIAL	GLAZING MATERIAL	OVERALL CONDITION	EXTERIOR FINISH	INTERIOR FINISH	GLASS	FRAME	SASHES	HARDWARE	GLAZING MATERIAL	WEATHERSTRIPPING	SUPPORT MATERIAL	SILL	PERIMETER SEALANT						
N-320-N		N	METAL	S.G.	FAIR	FAIR		Good	FAIR	N/A		BAD	BAD	FAIR	FAIR	BAD						
SCALE: 1/4" = 1'-0"						WINDOW SURVEY/WINDOW TYPES						TYPE N Sheet__of__										
DATE:			JOB NO.: 2023.113			VAN ZANDT COUNTY COURTHOUSE																
						121 E. DALLAS STREET CANTON, TEXAS 75103

① CLEAN/REPAINT

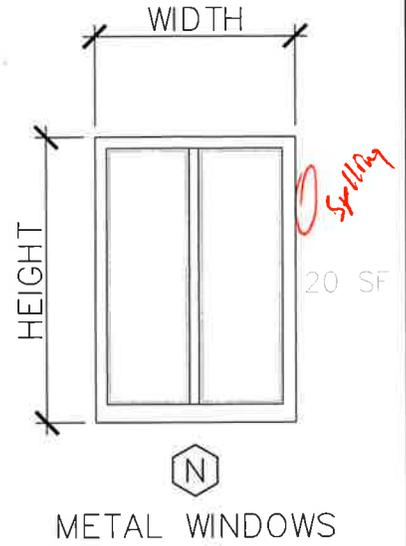
WINDOW					SPECIFIC CONDITION NOTES																	
WINDOW NO. 321	EXPOSURE	TYPE	FRAME MATERIAL	GLAZING MATERIAL	OVERALL CONDITION	EXTERIOR FINISH	INTERIOR FINISH	GLASS	FRAME	SASHES	HARDWARE	GLAZING MATERIAL	WEATHERSTRIPPING	SUPPORT MATERIAL	SILL	PERIMETER SEALANT						
N-321-N		N	METAL	S.G.	FAIR	FAIR		GOOD	FAIR	N/A		BAD	BAD	FAIR	FAIR	BAD						
SCALE: 1/4" = 1'-0"					WINDOW SURVEY/WINDOW TYPES																	
DATE:		JOB NO.: 2023.113			VAN ZANDT COUNTY COURTHOUSE																	
		KOMATSU ARCHITECTURE			121 E. DALLAS STREET CANTON, TEXAS 75103																	
TYPE N																						
Sheet ___ of ___

① CLEAN/REPAINT

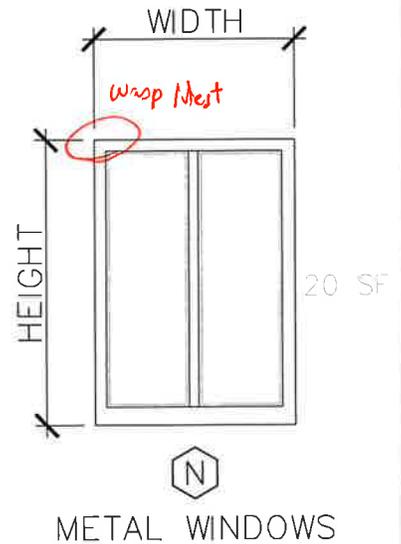
WINDOW				SPECIFIC CONDITION NOTES														
WINDOW NO. 322	EXPOSURE	TYPE	N	EXTERIOR FINISH	INTERIOR FINISH	GLASS	FRAME	SASHES	HARDWARE	GLAZING MATERIAL	WEATHERSTRIPPING	SUPPORT MATERIAL	SILL	PERIMETER SEALANT				
N-322-W				FAIR		Good	FAIR	N/A		BAD	BAD	Good	FAIR	BAD				
FRAME MATERIAL				GLAZING MATERIAL				OVERALL CONDITION										
METAL				S.G.				FAIR										
TYPE				N														
EXPOSURE																		
GLAZING MATERIAL																		
OVERALL CONDITION																		
EXTERIOR FINISH																		
INTERIOR FINISH																		
GLASS																		
FRAME																		
SASHES																		
HARDWARE																		
GLAZING MATERIAL												Rpl.						
WEATHERSTRIPPING												Rpl.						
SUPPORT MATERIAL												Stone						
SILL												FAIR						
PERIMETER SEALANT												Rpl.						
SCALE: 1/4" = 1'-0"				WINDOW SURVEY/WINDOW TYPES								TYPE N						
DATE:				JOB NO.: 2023.113				VAN ZANDT COUNTY COURTHOUSE

① CLEAN/REPAINT

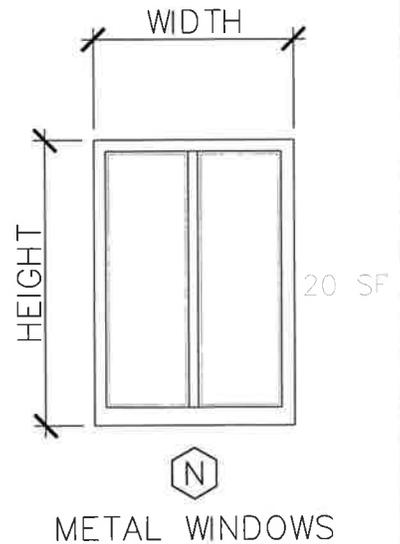
WINDOW				SPECIFIC CONDITION NOTES																			
WINDOW NO. 323	EXPOSURE	TYPE	N	EXTERIOR FINISH	INTERIOR FINISH	GLASS	FRAME	SASHES	HARDWARE	GLAZING MATERIAL	WEATHERSTRIPPING	SUPPORT MATERIAL	SILL	PERIMETER SEALANT									
N-323-W				FAIR		Good	FAIR	N/A		BAD	BAD	Good	FAIR	BAD									
SCALE: 1/4" = 1'-0"				WINDOW SURVEY/WINDOW TYPES																			
DATE:		JOB NO.: 2023.113		VAN ZANDT COUNTY COURTHOUSE										TYPE N									
				121 E. DALLAS STREET CANTON, TEXAS 75103										Sheet__of__

① CLEAN/REPAINT

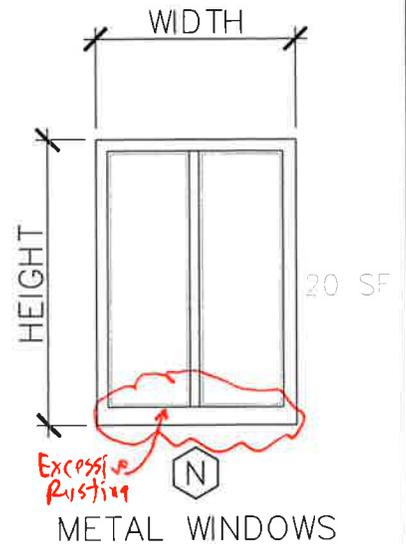
WINDOW					SPECIFIC CONDITION NOTES																
WINDOW NO. 324	EXPOSURE	TYPE	N		EXTERIOR FINISH	INTERIOR FINISH	GLASS	FRAME	SASHES	HARDWARE	GLAZING MATERIAL	WEATHERSTRIPPING	SUPPORT MATERIAL	SILL	PERIMETER SEALANT						
N-324-W					FAIR			GOOD	FAIR/POOR	N/A		BAD	BAD	GOOD	FAIR	BAD					
SCALE: 1/4" = 1'-0"					WINDOW SURVEY/WINDOW TYPES																
DATE:		JOB NO.: 2023.113			VAN ZANDT COUNTY COURTHOUSE										TYPE N						
KOMATSU ARCHITECTURE					121 E. DALLAS STREET CANTON, TEXAS 75103										Sheet ___ of ___

① CLEAN/REPAINT

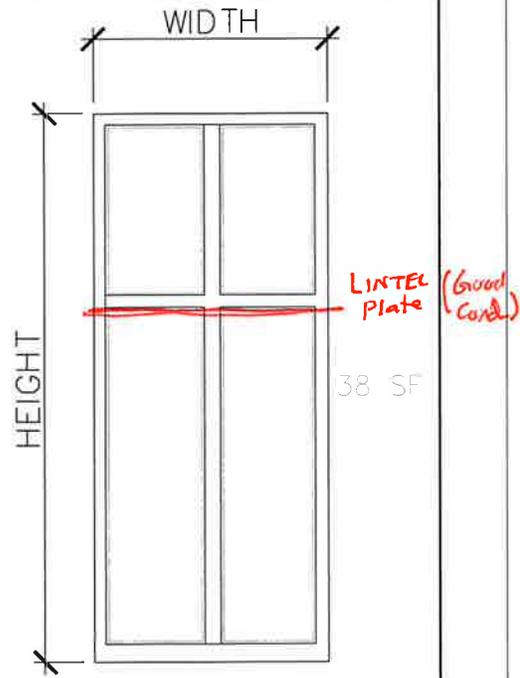
WINDOW				SPECIFIC CONDITION NOTES																			
P-325-W	325		P																				
WINDOW NO.	EXPOSURE	TYPE		EXTERIOR FINISH	INTERIOR FINISH	GLASS	FRAME	SASHES	HARDWARE	GLAZING MATERIAL	WEATHERSTRIPPING	SUPPORT MATERIAL	SILL	PERIMETER SEALANT									
		METAL		FAIR	FAIR	Good	FAIR	N/A		Bad Rpl.	Bad Rpl.	Good <i>Window damages @ header</i>	FAIR	Bad Rpl.									
SCALE: 1/4" = 1'-0"				WINDOW SURVEY/WINDOW TYPES																			
DATE:		JOB NO.: 2023.113		VAN ZANDT COUNTY COURTHOUSE																			
DATE:		JOB NO.: 2023.113		TYPE P																			
DATE:		JOB NO.: 2023.113		Sheet ___ of ___																			
				121 E. DALLAS STREET CANTON, TEXAS 75103

① CLEAN/REPAINT

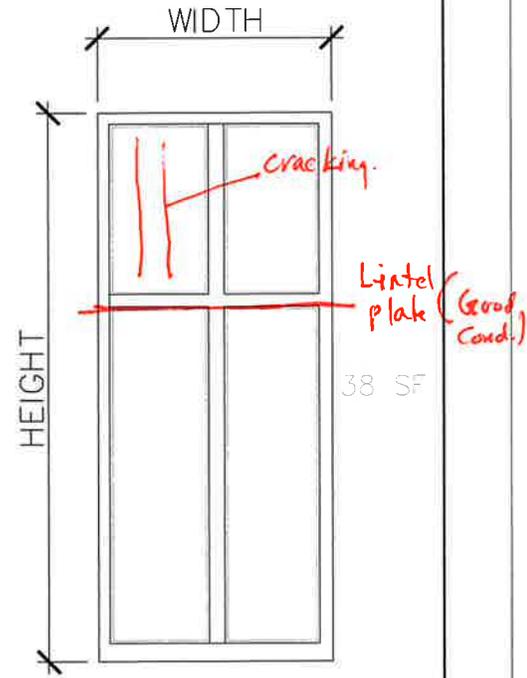
WINDOW		SPECIFIC CONDITION NOTES																		
P-326-W	326	EXPOSURE	TYPE P	FRAME MATERIAL	GLAZING MATERIAL	OVERALL CONDITION	EXTERIOR FINISH	INTERIOR FINISH	GLASS	FRAME	SASHES	HARDWARE	GLAZING MATERIAL	WEATHERSTRIPPING	SUPPORT MATERIAL	SILL	PERIMETER SEALANT			
				METAL	S.G.	Poor	Poor		Some cracked	Poor	N/A		Rpl.	Rpl.	Water damage @ header.	Poor	BAD			
SCALE: 1/4" = 1'-0"		WINDOW SURVEY/WINDOW TYPES										TYPE P								
DATE:	JOB NO.: 2023.113	VAN ZANDT COUNTY COURTHOUSE																		
		121 E. DALLAS STREET CANTON, TEXAS 75103										Sheet ___ of ___

① CLEAN/REPAINT

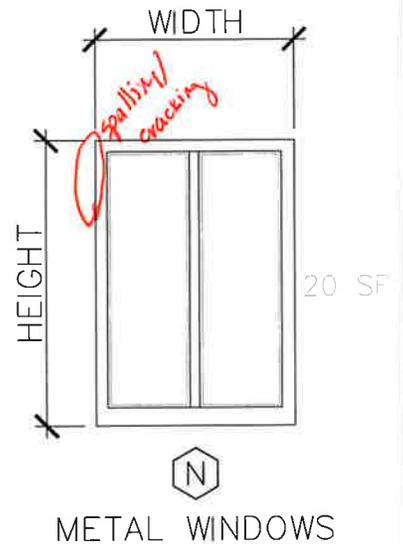
WINDOW		SPECIFIC CONDITION NOTES																		
WINDOW NO. 328	EXPOSURE	TYPE	FRAME MATERIAL	GLAZING MATERIAL	OVERALL CONDITION	EXTERIOR FINISH	INTERIOR FINISH	GLASS	FRAME	SASHES	HARDWARE	GLAZING MATERIAL	WEATHERSTRIPPING	SUPPORT MATERIAL	SILL	PERIMETER SEALANT				
N-328-W		N	METAL	S.G.	FAIR	FAIR	FAIR	Good	FAIR	N/A		BAD	BAD	Good	FAIR	BAD				
SCALE: 1/4" = 1'-0"						WINDOW SURVEY/WINDOW TYPES														
DATE:		JOB NO.: 2023.113				VAN ZANDT COUNTY COURTHOUSE														
KOMATSU ARCHITECTURE		121 E. DALLAS STREET CANTON, TEXAS 75103																		
TYPE N																				
Sheet ___ of ___

① CLEAN/REPAINT

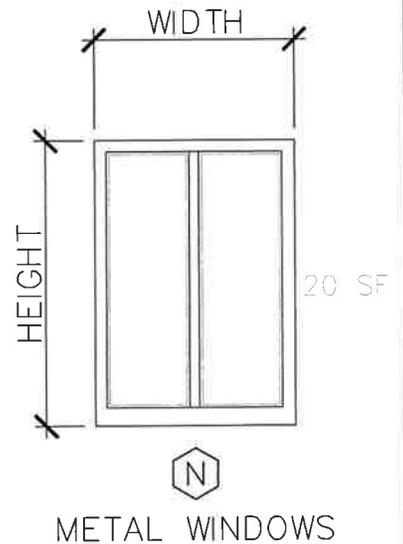
WINDOW		SPECIFIC CONDITION NOTES																				
WINDOW NO. 330	N	EXPOSURE	FRAME MATERIAL	GLAZING MATERIAL	OVERALL CONDITION	EXTERIOR FINISH	INTERIOR FINISH	GLASS	FRAME	SASHES	HARDWARE	GLAZING MATERIAL	WEATHERSTRIPPING	SUPPORT MATERIAL	SILL	PERIMETER SEALANT						
N-330-S			METAL	S.G.	FAIR	FAIR		<i>Good</i>	FAIR	<i>N/A</i>		BAD	BAD	<i>Good</i>	FAIR	BAD						
SCALE: 1/4" = 1'-0"		WINDOW SURVEY/WINDOW TYPES																				
DATE:	JOB NO.: 2023.113	VAN ZANDT COUNTY COURTHOUSE												TYPE N								
		121 E. DALLAS STREET CANTON, TEXAS 75103														Sheet ___ of ___

① CLEAN/REPAINT

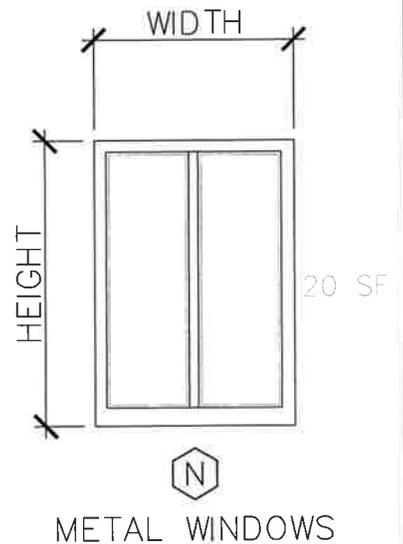
WINDOW					SPECIFIC CONDITION NOTES															
WINDOW NO. 331	EXPOSURE	TYPE N	FRAME MATERIAL	GLAZING MATERIAL	OVERALL CONDITION	EXTERIOR FINISH	INTERIOR FINISH	GLASS	FRAME	SASHES	HARDWARE	GLAZING MATERIAL	WEATHERSTRIPPING	SUPPORT MATERIAL	SILL	PERIMETER SEALANT				
N-331-S			METAL	S.G.	FAIR		FAIR	Good	FAIR	N/A		BAD	BAD	Good	FAIR	BAD				
SCALE: 1/4" = 1'-0"					WINDOW SURVEY/WINDOW TYPES															
DATE:		JOB NO.: 2023.113			VAN ZANDT COUNTY COURTHOUSE															
					121 E. DALLAS STREET CANTON, TEXAS 75103															
TYPE N																				
Sheet ___ of ___

① CLEAN/REPAINT

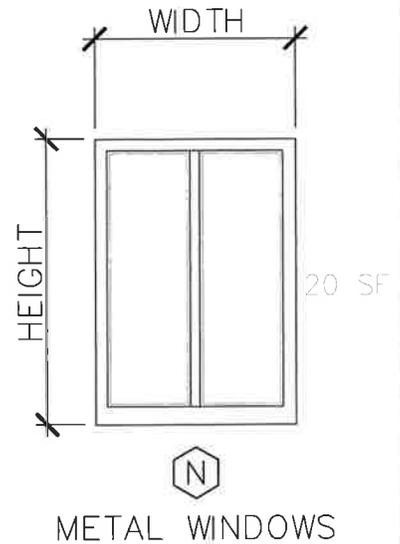
WINDOW				SPECIFIC CONDITION NOTES																		
WINDOW NO. 332	EXPOSURE	TYPE	N	EXTERIOR FINISH	INTERIOR FINISH	GLASS	FRAME	SASHES	HARDWARE	GLAZING MATERIAL	WEATHERSTRIPPING	SUPPORT MATERIAL	SILL	PERIMETER SEALANT								
N-332-S				FAIR	-	FAIR	FAIR	N/A		BAD	BAD	Good	FAIR	BAD								
SCALE: 1/4" = 1'-0"				WINDOW SURVEY/WINDOW TYPES																		
DATE:		JOB NO.: 2023.113		VAN ZANDT COUNTY COURTHOUSE																		
				TYPE N																		
				Sheet__of__																		
				121 E. DALLAS STREET CANTON, TEXAS 75103

① CLEAN/REPAINT

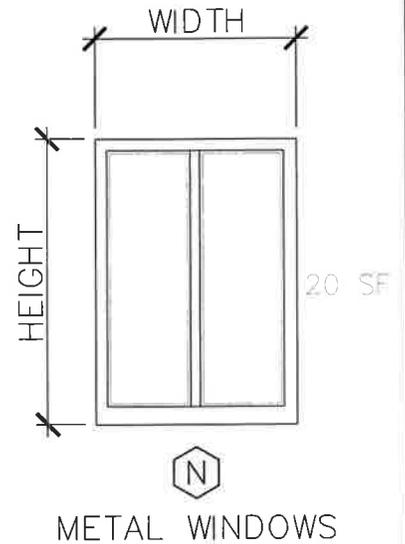
WINDOW				SPECIFIC CONDITION NOTES													
WINDOW NO. 334	EXPOSURE	TYPE	N	EXTERIOR FINISH	INTERIOR FINISH	GLASS	FRAME	SASHES	HARDWARE	GLAZING MATERIAL	WEATHERSTRIPPING	SUPPORT MATERIAL	SILL	PERIMETER SEALANT			
N-334-S		METAL		S.G.	FAIR	FAIR	GOOD	FAIR	N/A	BAD	BAD	GOOD	FAIR	BAD			
SCALE: 1/4" = 1'-0"				WINDOW SURVEY/WINDOW TYPES													
DATE:		JOB NO.: 2023.113		VAN ZANDT COUNTY COURTHOUSE										TYPE N			
KOMATSU ARCHITECTURE				121 E. DALLAS STREET CANTON, TEXAS 75103										Sheet ___ of ___

① CLEAN/REPAINT

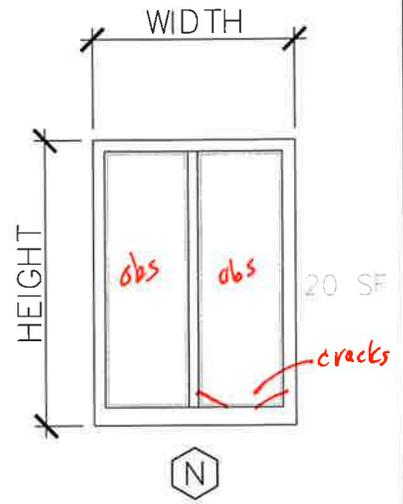
WINDOW						SPECIFIC CONDITION NOTES																	
WINDOW NO. 339	EXPOSURE	TYPE	N																				
N-339-S		METAL	S.G.	FAIR		FAIR		FAIR/BAD	<i>replace east pane</i>	FAIR	N/A		BAD	BAD	Good	FAIR	BAD						
SCALE: 1/4" = 1'-0"						WINDOW SURVEY/WINDOW TYPES						<h2 style="font-size: 2em;">TYPE N</h2> <p>Sheet__of__</p>											
DATE:			JOB NO.: 2023.113			VAN ZANDT COUNTY COURTHOUSE																	
						121 E. DALLAS STREET CANTON, TEXAS 75103

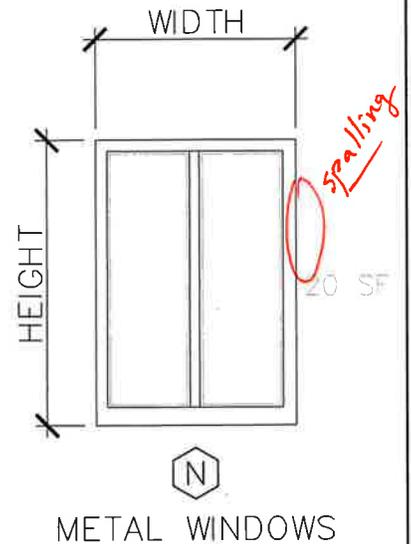
WINDOW					SPECIFIC CONDITION NOTES														
WINDOW NO. 342	EXPOSURE	TYPE	N		EXTERIOR FINISH	INTERIOR FINISH	GLASS	FRAME	SASHES	HARDWARE	GLAZING MATERIAL	WEATHERSTRIPPING	SUPPORT MATERIAL	SILL	PERIMETER SEALANT				
N-342-S		METAL	S.G.	FAIR	FAIR		GOOD	FAIR	N/A		BAD	BAD	Good/FAIR	FAIR	BAD				
SCALE: 1/4" = 1'-0"					WINDOW SURVEY/WINDOW TYPES														
DATE:		JOB NO.: 2023.113			VAN ZANDT COUNTY COURTHOUSE														
KOMATSU ARCHITECTURE					121 E. DALLAS STREET CANTON, TEXAS 75103														
															TYPE N				
															Sheet ___ of ___

① CLEAN/REPAINT

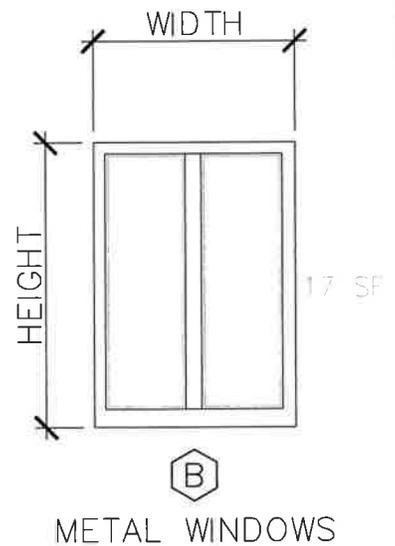
WINDOW					SPECIFIC CONDITION NOTES																		
WINDOW NO. 406	EXPOSURE	TYPE B	FRAME MATERIAL	GLAZING MATERIAL	OVERALL CONDITION	EXTERIOR FINISH	INTERIOR FINISH	GLASS	FRAME	SASHES	HARDWARE	GLAZING MATERIAL	WEATHERSTRIPPING	SUPPORT MATERIAL	SILL	PERIMETER SEALANT							
B-406-E			METAL	S.G.	FAIR	FAIR		Good	FAIR	N/A		BAD	BAD	Good	FAIR	BAD							
SCALE: 1/4" = 1'-0"						WINDOW SURVEY/WINDOW TYPES																	
DATE:		JOB NO.: 2023.113				VAN ZANDT COUNTY COURTHOUSE																	
						121 E. DALLAS STREET CANTON, TEXAS 75103																	
						TYPE B																	
						Sheet__of__

① CLEAN/REPAINT

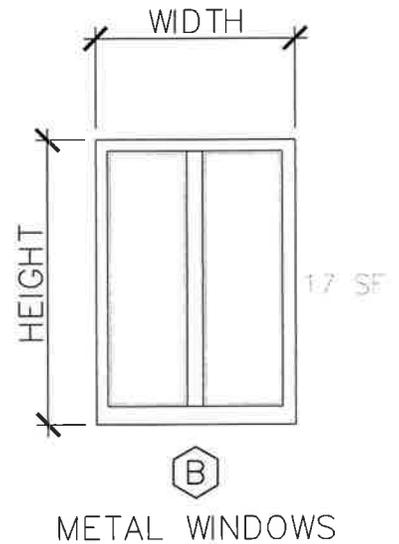
WINDOW		SPECIFIC CONDITION NOTES																				
WINDOW NO. 418	B																					
EXPOSURE	TYPE	FRAME MATERIAL	GLAZING MATERIAL	OVERALL CONDITION	EXTERIOR FINISH	INTERIOR FINISH	GLASS	FRAME	SASHES	HARDWARE	GLAZING MATERIAL	WEATHERSTRIPPING	SUPPORT MATERIAL	SILL	PERIMETER SEALANT							
B-418-W		METAL	S.G.	FAIR	FAIR		Good	FAIR	N/A		BAD	BAD	Good	FAIR	FAIR							
SCALE: 1/4" = 1'-0"		WINDOW SURVEY/WINDOW TYPES																				
DATE:	JOB NO.: 2023.113	VAN ZANDT COUNTY COURTHOUSE																				
		121 E. DALLAS STREET CANTON, TEXAS 75103																				
		TYPE B																				
		Sheet__of__

① CLEAN/REPAINT

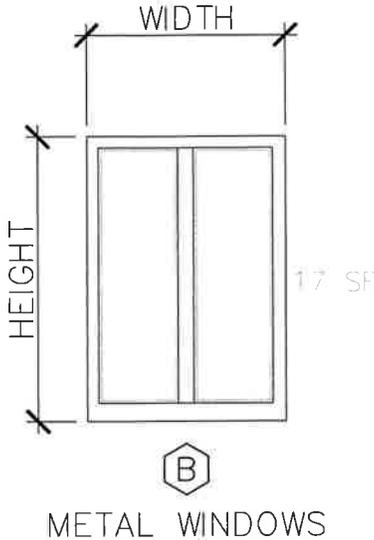
WINDOW		SPECIFIC CONDITION NOTES																				
WINDOW NO. 419																						
EXPOSURE	TYPE B	FRAME MATERIAL	GLAZING MATERIAL	OVERALL CONDITION	EXTERIOR FINISH	INTERIOR FINISH	GLASS	FRAME	SASHES	HARDWARE	GLAZING MATERIAL	WEATHERSTRIPPING	SUPPORT MATERIAL	SILL	PERIMETER SEALANT							
B-419-S		METAL	S.G.	Poor	Poor		Good	FAIR	N/A		BAD	BAD	Good	Poor	BAD							
SCALE: 1/4" = 1'-0"		WINDOW SURVEY/WINDOW TYPES												TYPE B								
DATE:	JOB NO.: 2023.113	VAN ZANDT COUNTY COURTHOUSE																				
		121 E. DALLAS STREET CANTON, TEXAS 75103												Sheet__of__

① CLEAN/REPAINT

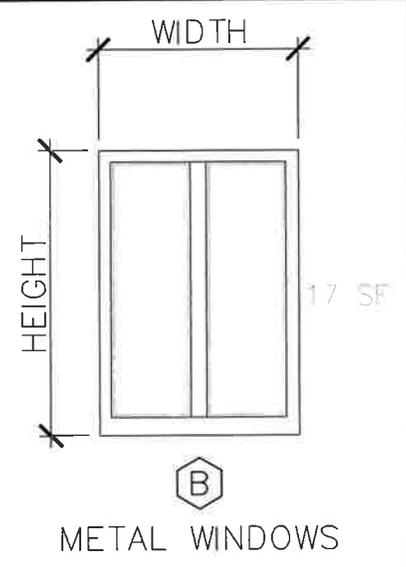
WINDOW				SPECIFIC CONDITION NOTES																			
WINDOW NO. 421	EXPOSURE	TYPE	B																				
FRAME MATERIAL	GLAZING MATERIAL	OVERALL CONDITION		EXTERIOR FINISH	INTERIOR FINISH	GLASS	FRAME	SASHES	HARDWARE	GLAZING MATERIAL	WEATHERSTRIPPING	SUPPORT MATERIAL	SILL	PERIMETER SEALANT									
METAL	S.G.	<i>Poor</i>		<i>Poor</i>		<i>Good</i>	<i>Poor</i>	<i>N/A</i>		<i>BAD</i>	<i>BAD</i>	<i>Good</i>	<i>Poor</i>	<i>BAD</i>									
SCALE: 1/4" = 1'-0"				WINDOW SURVEY/WINDOW TYPES																			
DATE:		JOB NO.: 2023.113		VAN ZANDT COUNTY COURTHOUSE																			
KOMATSU ARCHITECTURE				121 E. DALLAS STREET CANTON, TEXAS 75103																			
				TYPE B																			
				Sheet__of__

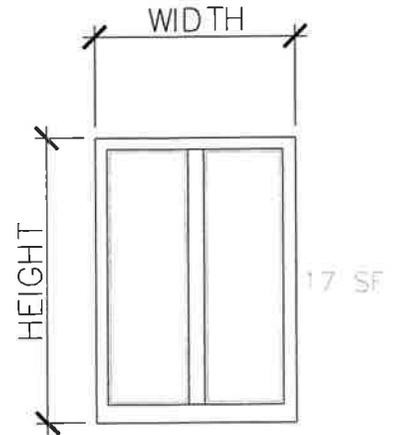
WINDOW		SPECIFIC CONDITION NOTES																		
WINDOW NO. 426	B																			
EXPOSURE	TYPE	FRAME MATERIAL	GLAZING MATERIAL	OVERALL CONDITION	EXTERIOR FINISH	INTERIOR FINISH	GLASS	FRAME	SASHES	HARDWARE	GLAZING MATERIAL	WEATHERSTRIPPING	SUPPORT MATERIAL	SILL	PERIMETER SEALANT					
B-426-S		METAL	S.G.	Poor	Poor		Good	Poor	N/A		BAD	BAD	Good	Poor	BAD					
SCALE: 1/4" = 1'-0"		WINDOW SURVEY/WINDOW TYPES																		
DATE:	JOB NO.: 2023.113	VAN ZANDT COUNTY COURTHOUSE																		
		121 E. DALLAS STREET CANTON, TEXAS 75103																		
		TYPE B																		
		Sheet__of__

① CLEAN/REPAINT

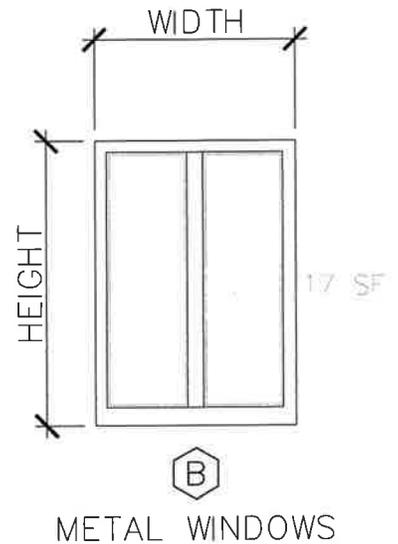
WINDOW				SPECIFIC CONDITION NOTES																			
WINDOW NO. 427	EXPOSURE	TYPE B																					
B-427-S	METAL	S.G.	Poor	Poor	Good	Poor	N/A	Bad	Bad	Good	Poor	Bad											
SCALE: 1/4" = 1'-0"				WINDOW SURVEY/WINDOW TYPES																			
DATE:		JOB NO.: 2023.113		VAN ZANDT COUNTY COURTHOUSE																			
KOMATSU ARCHITECTURE				121 E. DALLAS STREET CANTON, TEXAS 75103																			
				TYPE B																			
				Sheet__of__

① CLEAN/REPAINT

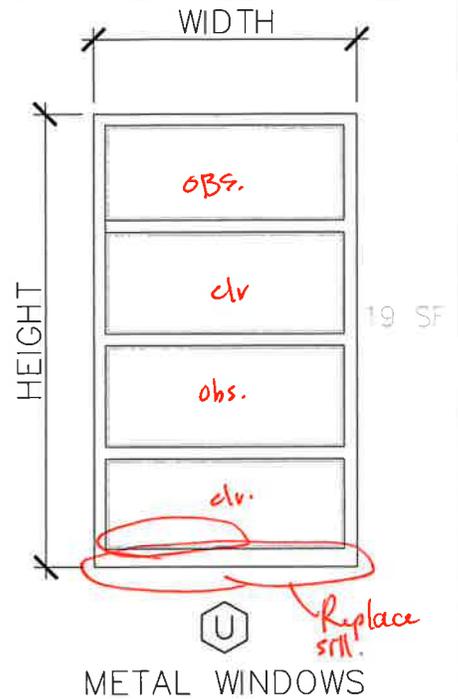
WINDOW				SPECIFIC CONDITION NOTES																
WINDOW NO. 501	EXPOSURE	TYPE U																		
				FRAME MATERIAL	GLAZING MATERIAL	OVERALL CONDITION	EXTERIOR FINISH	INTERIOR FINISH	GLASS	FRAME	SASHES	HARDWARE	GLAZING MATERIAL	WEATHERSTRIPPING	SUPPORT MATERIAL	SILL	PERIMETER SEALANT			
U-501-E				METAL	S.G.	Poor	Poor		Poor	Poor	N/A		Poor	Poor	Good	Poor	Poor			
SCALE: 1/4" = 1'-0"				WINDOW SURVEY/WINDOW TYPES										TYPE U						
DATE:		JOB NO.: 2023.113		VAN ZANDT COUNTY COURTHOUSE																
				121 E. DALLAS STREET CANTON, TEXAS 75103										Sheet ___ of ___

① CLEAN/REPAINT

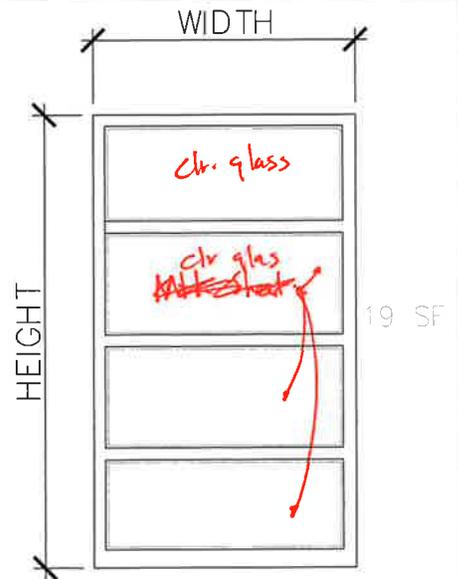
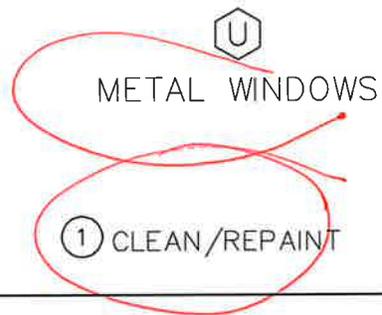
WINDOW				SPECIFIC CONDITION NOTES																			
U-503-E	503	U																					
WINDOW NO.	EXPOSURE	TYPE	FRAME MATERIAL	GLAZING MATERIAL	OVERALL CONDITION	EXTERIOR FINISH	INTERIOR FINISH	GLASS	FRAME	SASHES	HARDWARE	GLAZING MATERIAL	WEATHERSTRIPPING	SUPPORT MATERIAL	SILL	PERIMETER SEALANT							
			METAL	S.G.	Poor	Poor		Rep.	Rep.	N/A		Rep.	Rep.	Stone	Rusty	Rep.							
SCALE: 1/4" = 1'-0"				WINDOW SURVEY/WINDOW TYPES																			
DATE:		JOB NO.: 2023.113		VAN ZANDT COUNTY COURTHOUSE																			
				121 E. DALLAS STREET CANTON, TEXAS 75103																			
				TYPE U																			
				Sheet__of__

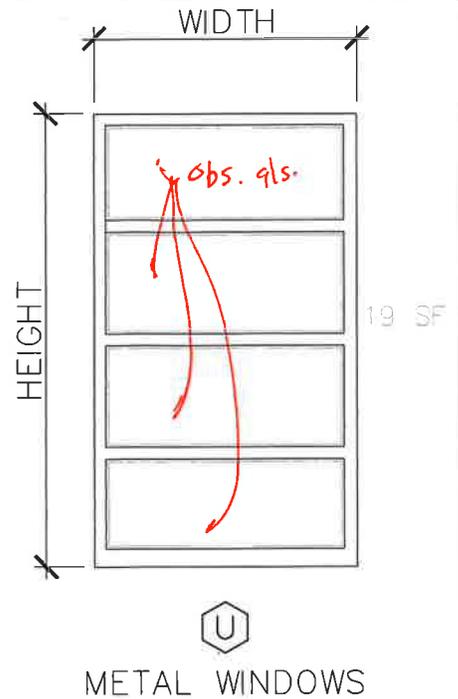
WINDOW				SPECIFIC CONDITION NOTES																	
WINDOW NO.	EXPOSURE	TYPE	U	EXTERIOR FINISH	INTERIOR FINISH	GLASS	FRAME	SASHES	HARDWARE	GLAZING MATERIAL	WEATHERSTRIPPING	SUPPORT MATERIAL	SILL	PERIMETER SEALANT							
504																					
U-504-E																					
	METAL	S.G.	Poor	Poor		BAD	Poor			BAD	BAD	Good	Poor	BAD							
SCALE: 1/4" = 1'-0"				WINDOW SURVEY/WINDOW TYPES										TYPE U							
DATE:		JOB NO.: 2023.113		VAN ZANDT COUNTY COURTHOUSE																	
				121 E. DALLAS STREET CANTON, TEXAS 75103										Sheet ___ of ___

① CLEAN/REPAINT

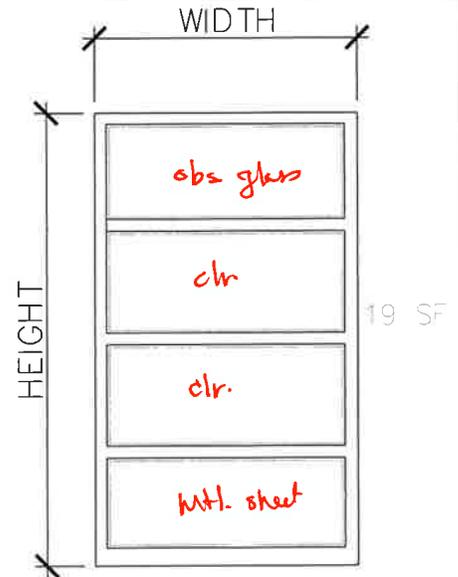
WINDOW				SPECIFIC CONDITION NOTES																			
WINDOW NO. 505			U																				
EXPOSURE	TYPE	FRAME MATERIAL	GLAZING MATERIAL	OVERALL CONDITION	EXTERIOR FINISH	INTERIOR FINISH	GLASS	FRAME	SASHES	HARDWARE	GLAZING MATERIAL	WEATHERSTRIPPING	SUPPORT MATERIAL	SILL	PERIMETER SEALANT								
U-505-E		METAL	S.G.	Poor	Poor		Rpl.	Poor			Rpl.	Rpl.	stain	Poor	Rpl.								
SCALE: 1/4" = 1'-0"				WINDOW SURVEY/WINDOW TYPES																			
DATE:		JOB NO.: 2023.113		VAN ZANDT COUNTY COURTHOUSE																			
				TYPE U																			
				Sheet__of__																			
				121 E. DALLAS STREET CANTON, TEXAS 75103

① CLEAN/REPAINT

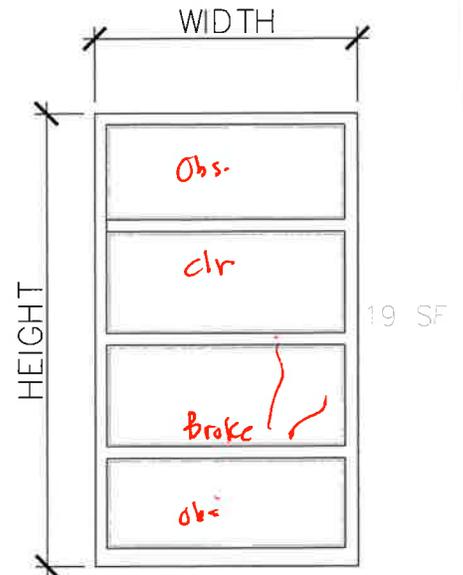
WINDOW				SPECIFIC CONDITION NOTES														
WINDOW NO. 506	EXPOSURE	TYPE	U	EXTERIOR FINISH	INTERIOR FINISH	GLASS	FRAME	SASHES	HARDWARE	GLAZING MATERIAL	WEATHERSTRIPPING	SUPPORT MATERIAL	SILL	PERIMETER SEALANT				
U-506-E		METAL		Poor		Bad	Poor	N/A		Bad	Bad	Good	Poor	Bad				
SCALE: 1/4" = 1'-0"				WINDOW SURVEY/WINDOW TYPES										TYPE U				
DATE:		JOB NO.: 2023.113		VAN ZANDT COUNTY COURTHOUSE														
				121 E. DALLAS STREET CANTON, TEXAS 75103										Sheet ___ of ___

① CLEAN/REPAINT

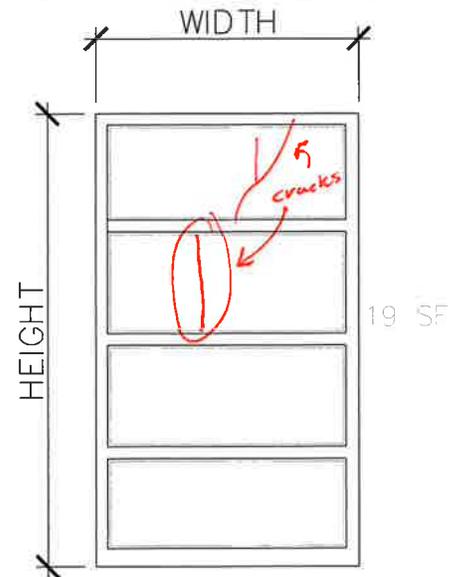
WINDOW		SPECIFIC CONDITION NOTES																		
WINDOW NO. 507	U	EXPOSURE	FRAME MATERIAL	GLAZING MATERIAL	OVERALL CONDITION	EXTERIOR FINISH	INTERIOR FINISH	GLASS	FRAME	SASHES	HARDWARE	GLAZING MATERIAL	WEATHERSTRIPPING	SUPPORT MATERIAL	SILL	PERIMETER SEALANT				
U-507-E			METAL	S.G.	<i>POOR</i>	<i>POOR</i>		<i>BAD</i>	<i>POOR</i>	<i>N/A</i>		<i>BAD</i>	<i>BAD</i>	<i>GOOD</i>	<i>FAIR</i>	<i>BAD</i>				
SCALE: 1/4" = 1'-0"						WINDOW SURVEY/WINDOW TYPES						TYPE U								
DATE:		JOB NO.: 2023.113		VAN ZANDT COUNTY COURTHOUSE						Sheet ___ of ___										
		121 E. DALLAS STREET CANTON, TEXAS 75103

① CLEAN/REPAINT

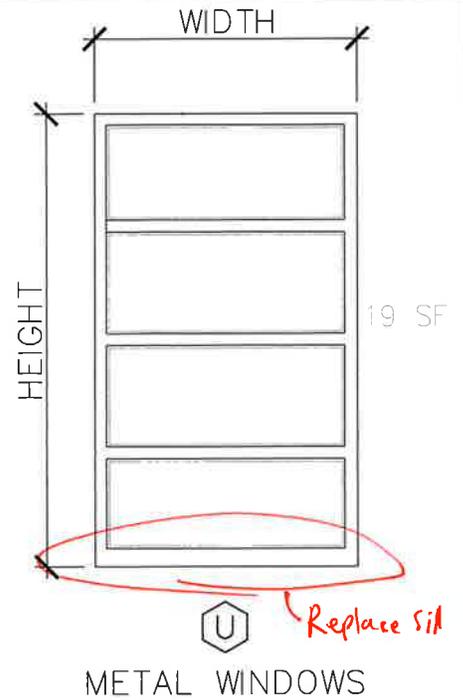
WINDOW				SPECIFIC CONDITION NOTES														
WINDOW NO. 508	EXPOSURE	TYPE	U	EXTERIOR FINISH	INTERIOR FINISH	GLASS	FRAME	SASHES	HARDWARE	GLAZING MATERIAL	WEATHERSTRIPPING	SUPPORT MATERIAL	SILL	PERIMETER SEALANT				
U-508-E				POOR		BAD	POOR	N/A		BAD	BAD	GOOD	BAD	BAD

① CLEAN/REPAINT

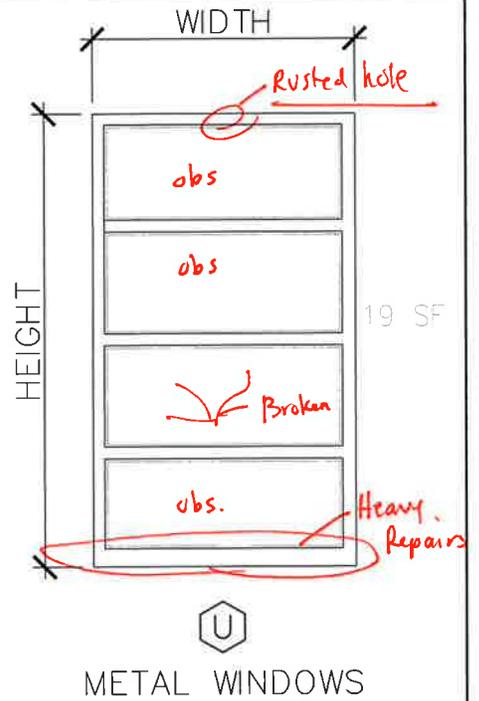
WINDOW		SPECIFIC CONDITION NOTES													
WINDOW NO. 509	U	EXTERIOR FINISH	INTERIOR FINISH	GLASS	FRAME	SASHES	HARDWARE	GLAZING MATERIAL	WEATHERSTRIPPING	SUPPORT MATERIAL	SILL	PERIMETER SEALANT			
U-509-N		METAL	S.G.	Poor	Poor	Bad Rpl	Poor	N/A	Bad Rpl.	Bad Rpl.	Good stone	Poor Extensive repairs needed	Bad		
SCALE: 1/4" = 1'-0"		WINDOW SURVEY/WINDOW TYPES										TYPE U			
DATE:	JOB NO.: 2023.113	VAN ZANDT COUNTY COURTHOUSE													
		121 E. DALLAS STREET CANTON, TEXAS 75103										Sheet ___ of ___

① CLEAN/REPAINT

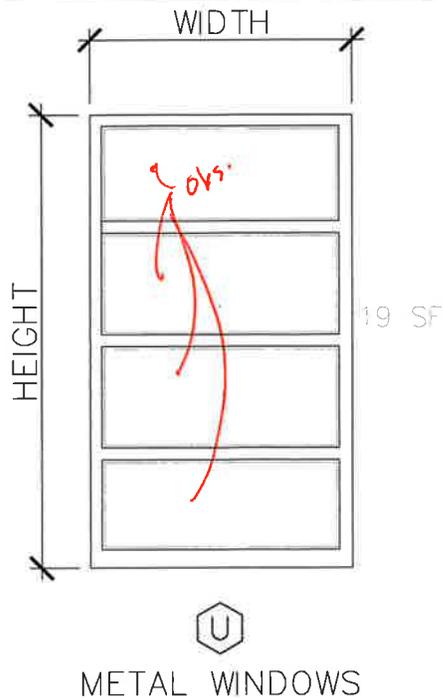
WINDOW				SPECIFIC CONDITION NOTES														
WINDOW NO. 510	EXPOSURE	TYPE	U	EXTERIOR FINISH	INTERIOR FINISH	GLASS	FRAME	SASHES	HARDWARE	GLAZING MATERIAL	WEATHERSTRIPPING	SUPPORT MATERIAL	SILL	PERIMETER SEALANT				
U-510-N				FAIR		BAD	FAIR	N/A		BAD	BAD	Good	Poor	BAD				
SCALE: 1/4" = 1'-0"				WINDOW SURVEY/WINDOW TYPES														
DATE:				JOB NO.: 2023.113				VAN ZANDT COUNTY COURTHOUSE				TYPE U						
KOMATSU ARCHITECTURE				121 E. DALLAS STREET CANTON, TEXAS 75103				Sheet__of__

① CLEAN/REPAINT

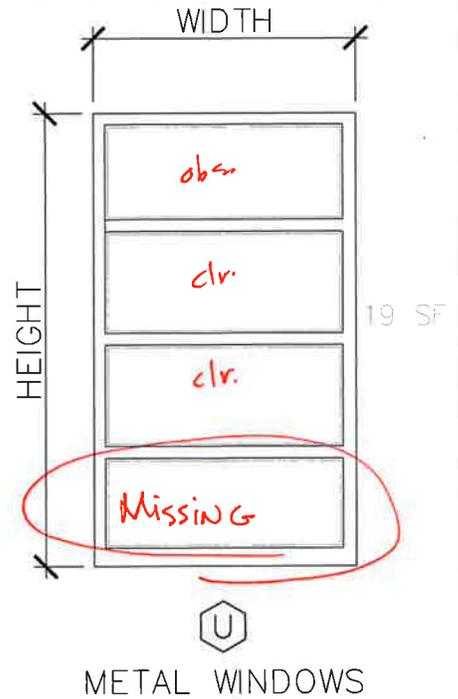
WINDOW				SPECIFIC CONDITION NOTES														
WINDOW NO. 511	EXPOSURE	TYPE U		EXTERIOR FINISH	INTERIOR FINISH	GLASS	FRAME	SASHES	HARDWARE	GLAZING MATERIAL	WEATHERSTRIPPING	SUPPORT MATERIAL	SILL	PERIMETER SEALANT				
U-511-N			METAL	S.G.	Poor													
						Repl					Repl	Repl	stone	Repl.	Repl			
						Bad	Poor	N/A			Bad	Bad	Good	Bad	Bad			
SCALE: 1/4" = 1'-0"				WINDOW SURVEY/WINDOW TYPES														
DATE:		JOB NO.: 2023.113		VAN ZANDT COUNTY COURTHOUSE														
KOMATSU ARCHITECTURE				121 E. DALLAS STREET CANTON, TEXAS 75103														
				TYPE U														
				Sheet ___ of ___

① CLEAN/REPAINT

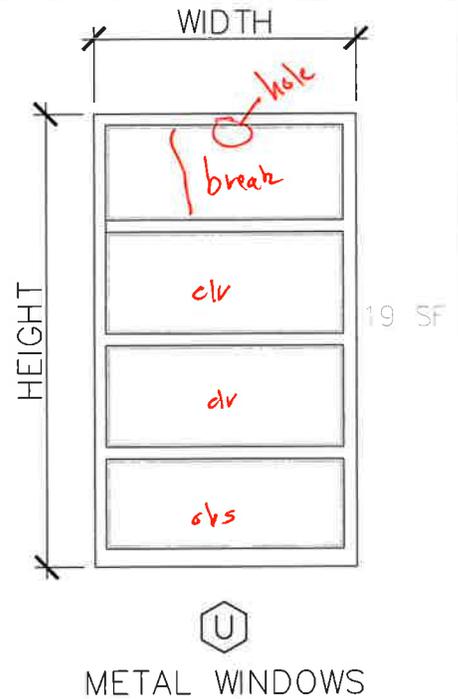
WINDOW				SPECIFIC CONDITION NOTES														
WINDOW NO. 512	EXPOSURE	TYPE U		EXTERIOR FINISH	INTERIOR FINISH	GLASS	FRAME	SASHES	HARDWARE	GLAZING MATERIAL	WEATHERSTRIPPING	SUPPORT MATERIAL	SILL	PERIMETER SEALANT				
U-512-N			METAL	S.G.	Poor	Poor	BAD	Poor	N/A	BAD	BAD	Good	Poor	BAD				
SCALE: 1/4" = 1'-0"				WINDOW SURVEY/WINDOW TYPES														
DATE:		JOB NO.: 2023.113		VAN ZANDT COUNTY COURTHOUSE										TYPE U				
KOMATSU ARCHITECTURE				121 E. DALLAS STREET CANTON, TEXAS 75103										Sheet ___ of ___

① CLEAN/REPAINT

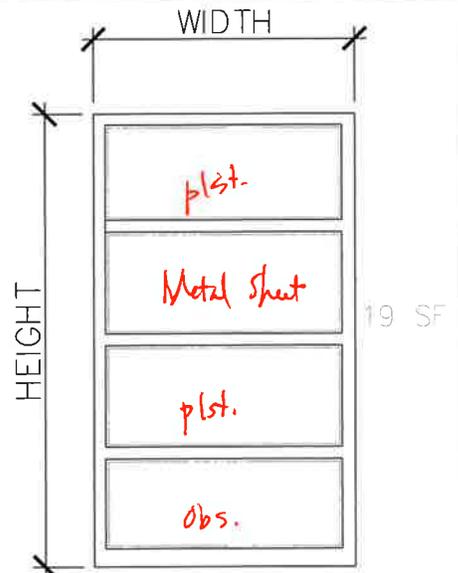
WINDOW		SPECIFIC CONDITION NOTES																			
513	U	EXPOSURE	TYPE	FRAME MATERIAL	GLAZING MATERIAL	OVERALL CONDITION	EXTERIOR FINISH	INTERIOR FINISH	GLASS	FRAME	SASHES	HARDWARE	GLAZING MATERIAL	WEATHERSTRIPPING	SUPPORT MATERIAL	SILL	PERIMETER SEALANT				
U-513-N				METAL	S.G.	<i>Poor</i>	<i>Poor</i>		<i>BAD</i>	<i>Poor</i>	<i>N/A</i>		<i>BAD</i>	<i>BAD</i>	<i>Good</i>	<i>Poor</i>	<i>BAD</i>				
SCALE: 1/4" = 1'-0"		WINDOW SURVEY/WINDOW TYPES												TYPE U							
DATE:	JOB NO.: 2023.113	VAN ZANDT COUNTY COURTHOUSE																			
KOMATSU ARCHITECTURE		121 E. DALLAS STREET CANTON, TEXAS 75103												Sheet__of__

① CLEAN/REPAINT

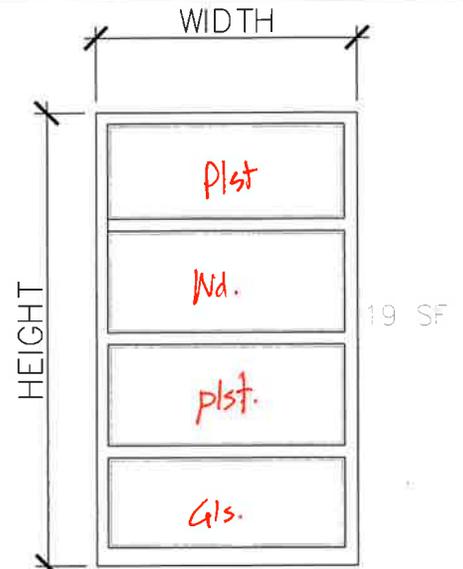
WINDOW				SPECIFIC CONDITION NOTES														
WINDOW NO. 514	EXPOSURE	TYPE	U	EXTERIOR FINISH	INTERIOR FINISH	GLASS	FRAME	SASHES	HARDWARE	GLAZING MATERIAL	WEATHERSTRIPPING	SUPPORT MATERIAL	SILL	PERIMETER SEALANT				
U-514-N				POOR/FAIR		BAD	POOR	N/A		BAD	BAD	GOOD	POOR	BAD				
SCALE: 1/4" = 1'-0"				WINDOW SURVEY/WINDOW TYPES														
DATE:				JOB NO.: 2023.113														
				VAN ZANDT COUNTY COURTHOUSE														
				121 E. DALLAS STREET CANTON, TEXAS 75103														
				TYPE U														
				Sheet__of__

① CLEAN/REPAINT

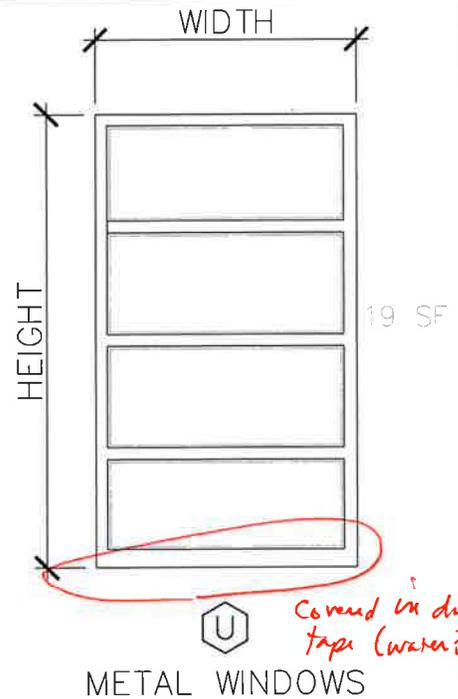
WINDOW				SPECIFIC CONDITION NOTES													
WINDOW NO. 515	EXPOSURE	TYPE	U	EXTERIOR FINISH	INTERIOR FINISH	GLASS	FRAME	SASHES	HARDWARE	GLAZING MATERIAL	WEATHERSTRIPPING	SUPPORT MATERIAL	SILL	PERIMETER SEALANT			
U-515-N				FAIR Poor		BAD	Poor	N/A		BAD	BAD	Good frame	Poor → BAD	BAD			
SCALE: 1/4" = 1'-0"				WINDOW SURVEY/WINDOW TYPES													
DATE:		JOB NO.: 2023.113		VAN ZANDT COUNTY COURTHOUSE													
				121 E. DALLAS STREET CANTON, TEXAS 75103													
														TYPE U			
														Sheet ___ of ___

① CLEAN/REPAINT

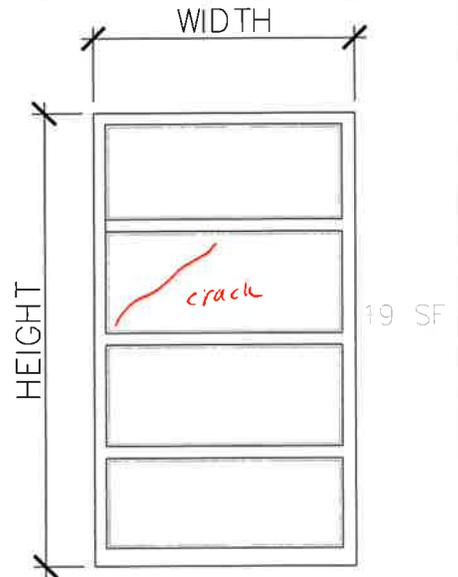
WINDOW				SPECIFIC CONDITION NOTES														
WINDOW NO. 516	EXPOSURE	TYPE U		EXTERIOR FINISH	INTERIOR FINISH	GLASS	FRAME	SASHES	HARDWARE	GLAZING MATERIAL	WEATHERSTRIPPING	SUPPORT MATERIAL	SILL	PERIMETER SEALANT				
U-516-N			METAL	S.G.	Poor	Poor	BAO	Poor	N/A	BAO	BAO	Good	Poor	BAO				
SCALE: 1/4" = 1'-0"				WINDOW SURVEY/WINDOW TYPES														
DATE:		JOB NO.: 2023.113		VAN ZANDT COUNTY COURTHOUSE														
				121 E. DALLAS STREET CANTON, TEXAS 75103														
				<p style="text-align: right; font-size: 2em; margin: 0;">TYPE U</p> <p style="text-align: right; margin: 0;">Sheet ___ of ___</p>

① CLEAN/REPAINT

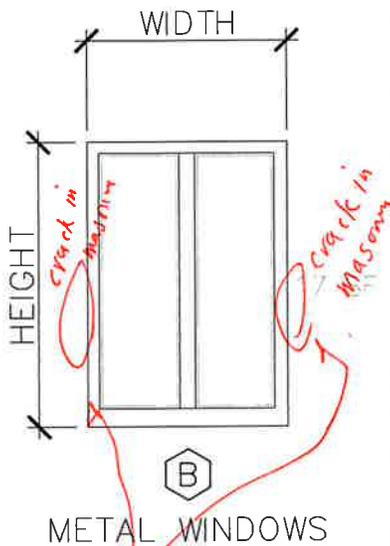
WINDOW		SPECIFIC CONDITION NOTES																					
WINDOW NO. 517	EXPOSURE	TYPE	B																				
				FRAME MATERIAL	GLAZING MATERIAL	OVERALL CONDITION		EXTERIOR FINISH	INTERIOR FINISH	GLASS	FRAME	SASHES	HARDWARE	GLAZING MATERIAL	WEATHERSTRIPPING	SUPPORT MATERIAL	SILL	PERIMETER SEALANT					
B-517-N				METAL	S.G.	<i>Poor</i>		<i>Poor</i>		<i>Good</i>	<i>Poor</i>	<i>N/A</i>		<i>BAD</i>	<i>BAD</i>	<i>FAIR</i>	<i>Poor</i>	<i>BAD</i>

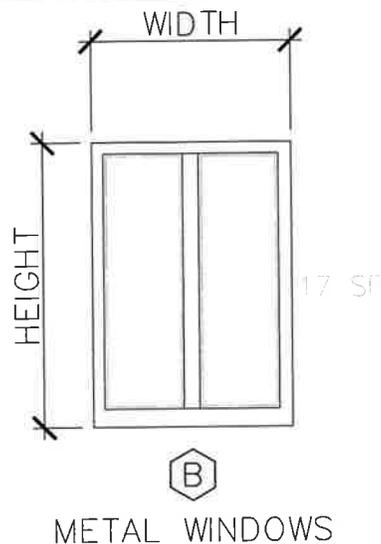
WINDOW				SPECIFIC CONDITION NOTES																			
WINDOW NO. 518	EXPOSURE	TYPE	B	FRAME MATERIAL	GLAZING MATERIAL	OVERALL CONDITION	EXTERIOR FINISH	INTERIOR FINISH	GLASS	FRAME	SASHES	HARDWARE	GLAZING MATERIAL	WEATHERSTRIPPING	SUPPORT MATERIAL	SILL	PERIMETER SEALANT						
B-518-N				METAL	S.G.	POOR FAIR	FAIR		<i>Good</i>	FAIR	N/A		BAD	BAD	<i>Good</i>	FAIR	BAD						
SCALE: 1/4" = 1'-0"				WINDOW SURVEY/WINDOW TYPES																			
DATE:		JOB NO.: 2023.113		VAN ZANDT COUNTY COURTHOUSE																			
KOMATSU ARCHITECTURE				121 E. DALLAS STREET CANTON, TEXAS 75103																			
TYPE B																							
Sheet ___ of ___

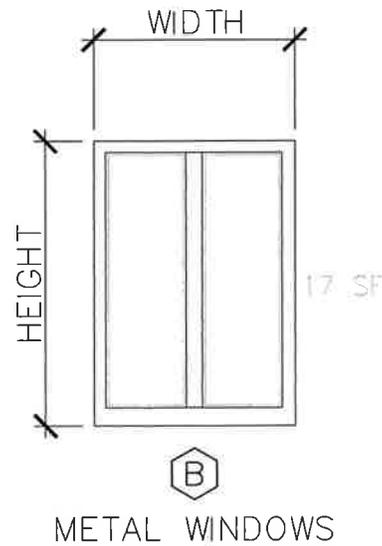
WINDOW				SPECIFIC CONDITION NOTES																			
WINDOW NO. 520	EXPOSURE	TYPE	B	EXTERIOR FINISH	INTERIOR FINISH	GLASS	FRAME	SASHES	HARDWARE	GLAZING MATERIAL	WEATHERSTRIPPING	SUPPORT MATERIAL	SILL	PERIMETER SEALANT									
B-520-W				Poor		Good	FAIR	N/A		BAD	BAD	Good Stone	FAIR	BAD									
SCALE: 1/4" = 1'-0"				WINDOW SURVEY/WINDOW TYPES																			
DATE:		JOB NO.: 2023.113		VAN ZANDT COUNTY COURTHOUSE																			
				121 E. DALLAS STREET CANTON, TEXAS 75103																			
														TYPE B									
														Sheet__of__

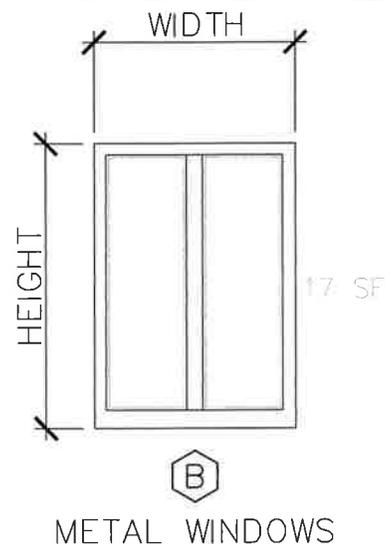
WINDOW				SPECIFIC CONDITION NOTES																			
WINDOW NO. 521	EXPOSURE	TYPE B	FRAME MATERIAL	GLAZING MATERIAL	OVERALL CONDITION	EXTERIOR FINISH	INTERIOR FINISH	GLASS	FRAME	SASHES	HARDWARE	GLAZING MATERIAL	WEATHERSTRIPPING	SUPPORT MATERIAL	SILL	PERIMETER SEALANT							
B-521-W			METAL	S.G.	FAIR	Poor		Good	FAIR	N/A		BAD	BAD	Good	FAIR	BAD							
SCALE: 1/4" = 1'-0"						WINDOW SURVEY/WINDOW TYPES						TYPE B											
DATE:		JOB NO.: 2023.113				VAN ZANDT COUNTY COURTHOUSE																	
KOMATSU ARCHITECTURE		121 E. DALLAS STREET CANTON, TEXAS 75103						Sheet__of__

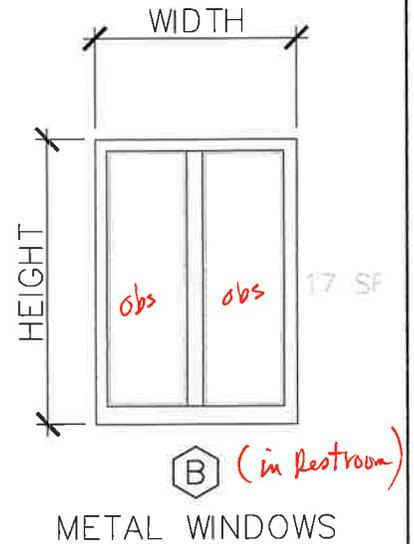
WINDOW		SPECIFIC CONDITION NOTES																				
WINDOW NO. 522	B																					
EXPOSURE	TYPE	FRAME MATERIAL	GLAZING MATERIAL	OVERALL CONDITION	EXTERIOR FINISH	INTERIOR FINISH	GLASS	FRAME	SASHES	HARDWARE	GLAZING MATERIAL	WEATHERSTRIPPING	SUPPORT MATERIAL	SILL	PERIMETER SEALANT							
B-522-W		METAL	S.G.	FAIR	FAIR		FAIR Obscured for R/R use	FAIR	N/A		BAD	BAD	GOOD	FAIR	BAD							
SCALE: 1/4" = 1'-0"		WINDOW SURVEY/WINDOW TYPES																				
DATE:	JOB NO.: 2023.113	VAN ZANDT COUNTY COURTHOUSE																				
		121 E. DALLAS STREET CANTON, TEXAS 75103																				
		TYPE B																				
		Sheet ___ of ___

① CLEAN/REPAINT

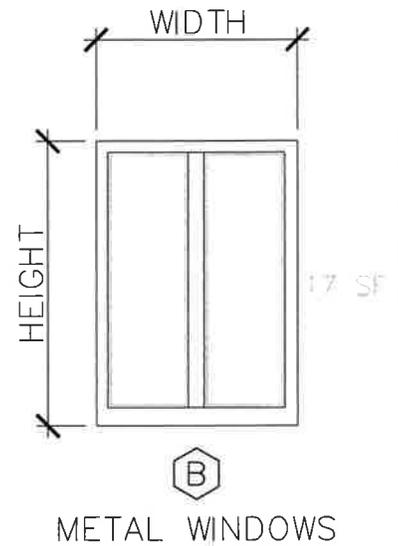
WINDOW					SPECIFIC CONDITION NOTES															
WINDOW NO. 523	EXPOSURE	TYPE	FRAME MATERIAL	GLAZING MATERIAL	OVERALL CONDITION	EXTERIOR FINISH	INTERIOR FINISH	GLASS	FRAME	SASHES	HARDWARE	GLAZING MATERIAL	WEATHERSTRIPPING	SUPPORT MATERIAL	SILL	PERIMETER SEALANT				
B-523-W		B	METAL	S.G.	FAIR	FAIR		GOOD	FAIR	N/A		BAD	BAD	GOOD	FAIR	BAD				
SCALE: 1/4" = 1'-0"					WINDOW SURVEY/WINDOW TYPES															
DATE:					JOB NO.: 2023.113															
					VAN ZANDT COUNTY COURTHOUSE 121 E. DALLAS STREET CANTON, TEXAS 75103										TYPE B Sheet__of__

① CLEAN/REPAINT

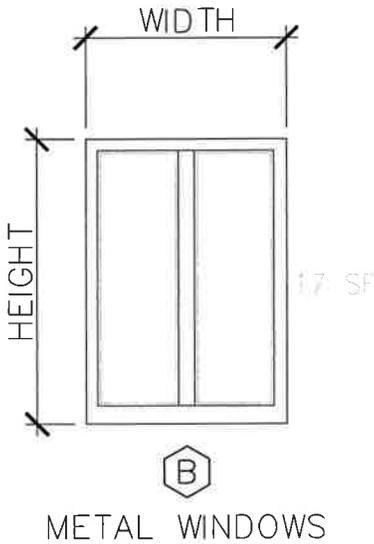
WINDOW				SPECIFIC CONDITION NOTES														
WINDOW NO. 524	EXPOSURE	TYPE B		EXTERIOR FINISH	INTERIOR FINISH	GLASS	FRAME	SASHES	HARDWARE	GLAZING MATERIAL	WEATHERSTRIPPING	SUPPORT MATERIAL	SILL	PERIMETER SEALANT				
B-524-W		METAL	S.G.	Poor		Good	Poor	N/A		Replace	Replace	Stone		Replace				
SCALE: 1/4" = 1'-0"				WINDOW SURVEY/WINDOW TYPES														
DATE:		JOB NO.: 2023.113		VAN ZANDT COUNTY COURTHOUSE										TYPE B				
KOMATSU ARCHITECTURE				121 E. DALLAS STREET CANTON, TEXAS 75103										Sheet__of__

① CLEAN/REPAINT
