VAN ZANDT COUNTY COURTHOUSE
 121 E. DALLAS ST.
 CANTON, TX 75103

DATE	06/04/2020
PROJECT NO.	1608818045
SHEET NO.	A2.001
1ST FLOOR EXISTING & DEMOLITION

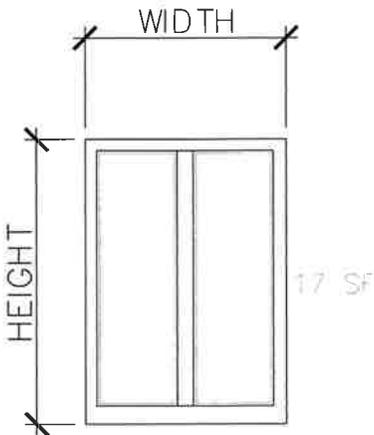
WINDOW		SPECIFIC CONDITION NOTES																				
WINDOW NO. 525	EXPOSURE	TYPE	FRAME MATERIAL	GLAZING MATERIAL	OVERALL CONDITION	EXTERIOR FINISH	INTERIOR FINISH	GLASS	FRAME	SASHES	HARDWARE	GLAZING MATERIAL	WEATHERSTRIPPING	SUPPORT MATERIAL	SILL	PERIMETER SEALANT						
B-525-W		B	METAL	✓ S.G.	Poor	Poor	Rusty	Good	Poor	N/A		Rep.	Rep.	Stone	Rust.	Rep.						
SCALE: 1/4" = 1'-0"		WINDOW SURVEY/WINDOW TYPES												TYPE B								
DATE:	JOB NO.: 2023.113	VAN ZANDT COUNTY COURTHOUSE																				
		121 E. DALLAS STREET CANTON, TEXAS 75103												Sheet ___ of ___

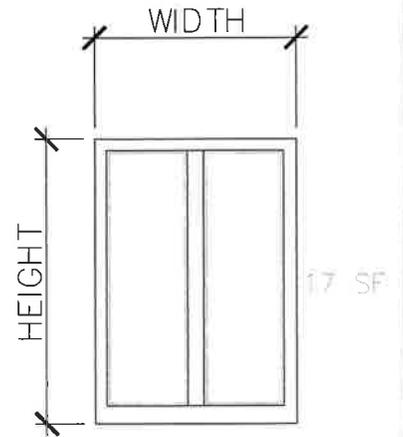
WINDOW		SPECIFIC CONDITION NOTES																			
WINDOW NO. 526	TYPE B	EXPOSURE	FRAME MATERIAL	GLAZING MATERIAL	OVERALL CONDITION	EXTERIOR FINISH	INTERIOR FINISH	GLASS	FRAME	SASHES	HARDWARE	GLAZING MATERIAL	WEATHERSTRIPPING	SUPPORT MATERIAL	SILL	PERIMETER SEALANT					
B-526-W			METAL	S.G.	Poor	Poor		Good	FAIR	N/A		Replace	Replace	Good	Poor	BAD

① CLEAN/REPAINT

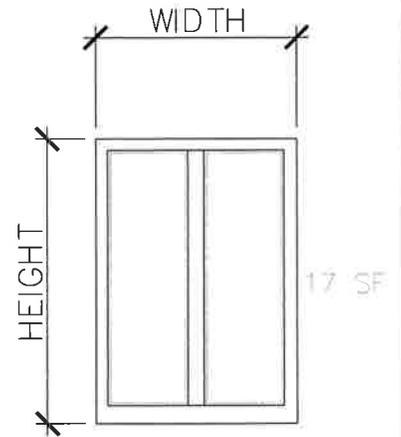
WINDOW					SPECIFIC CONDITION NOTES																		
WINDOW NO. 527	EXPOSURE	TYPE B	FRAME MATERIAL	GLAZING MATERIAL	OVERALL CONDITION	EXTERIOR FINISH	INTERIOR FINISH	GLASS	FRAME	SASHES	HARDWARE	GLAZING MATERIAL	WEATHERSTRIPPING	SUPPORT MATERIAL	SILL	PERIMETER SEALANT							
B-527-S			METAL	S.G.	Poor	Poor	Rusty	Good	Poor	N/A		Replace	Replace	(Stone)	Poor	Replace							
SCALE: 1/4" = 1'-0"					WINDOW SURVEY/WINDOW TYPES																		
DATE:		JOB NO.: 2023.113			VAN ZANDT COUNTY COURTHOUSE																		
					121 E. DALLAS STREET CANTON, TEXAS 75103																		
TYPE B																							
Sheet ___ of ___

① CLEAN/REPAINT

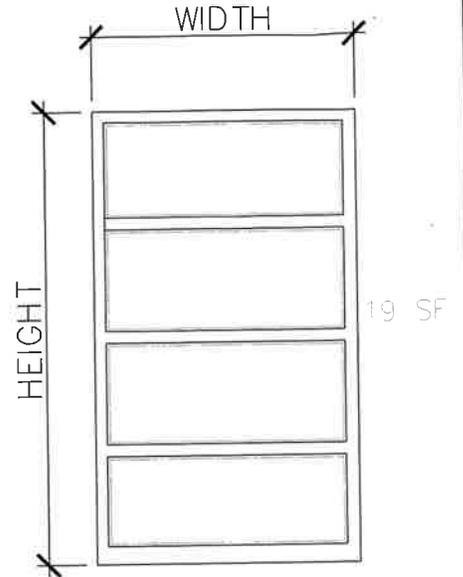
WINDOW				SPECIFIC CONDITION NOTES																	
WINDOW NO. 528	EXPOSURE	TYPE	U	EXTERIOR FINISH	INTERIOR FINISH	GLASS	FRAME	SASHES	HARDWARE	GLAZING MATERIAL	WEATHERSTRIPPING	SUPPORT MATERIAL	SILL	PERIMETER SEALANT							
U-528-S		METAL		Poor		FAIR	POOR	N/A		BAD	BAD	GOOD	Poor	BAD							
SCALE: 1/4" = 1'-0"				WINDOW SURVEY/WINDOW TYPES																	
DATE:				JOB NO.: 2023.113																	
				VAN ZANDT COUNTY COURTHOUSE 121 E. DALLAS STREET CANTON, TEXAS 75103																	
				TYPE U Sheet ___ of ___

① CLEAN/REPAINT

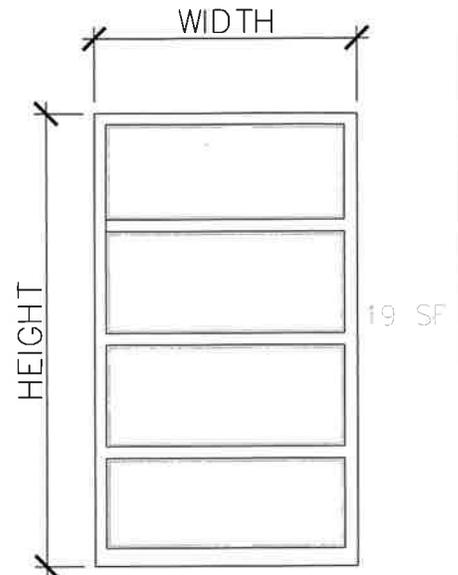
WINDOW NO. 530	EXPOSURE	TYPE U																	
	FRAME MATERIAL	GLAZING MATERIAL	OVERALL CONDITION	EXTERIOR FINISH	INTERIOR FINISH	GLASS	FRAME	SASHES	HARDWARE	GLAZING MATERIAL	WEATHERSTRIPPING	SUPPORT MATERIAL	SILL	PERIMETER SEALANT					
U-530-S	METAL	S.G.	<i>Poor</i>	<i>Poor</i>		<i>Poor</i>	<i>Poor</i>	<i>N/A</i>		<i>BAD</i>	<i>BAD</i>	<i>Good</i>	<i>Poor</i>	<i>BAD</i>

① CLEAN/REPAINT

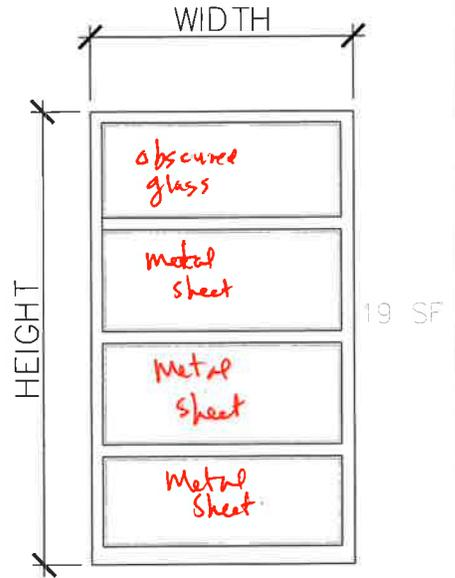
WINDOW				SPECIFIC CONDITION NOTES													
531	WINDOW NO. 530 532	EXPOSURE	TYPE U	EXTERIOR FINISH	INTERIOR FINISH	GLASS	FRAME	SASHES	HARDWARE	GLAZING MATERIAL	WEATHERSTRIPPING	SUPPORT MATERIAL	SILL	PERIMETER SEALANT			
				Poor		Rpl.	Poor	N/A		Ppl.	Rpl.	Stone	Poor	Ppl.			
		METAL				BAD	Poor			BAD	BAD	Good	Poor	BAD			
		S.G.															
		OVERALL CONDITION															
SCALE: 1/4" = 1'-0"				WINDOW SURVEY/WINDOW TYPES													
DATE:				JOB NO.: 2023.113													
				VAN ZANDT COUNTY COURTHOUSE 121 E. DALLAS STREET CANTON, TEXAS 75103													
				TYPE U													
				Sheet ___ of ___

① CLEAN/REPAINT

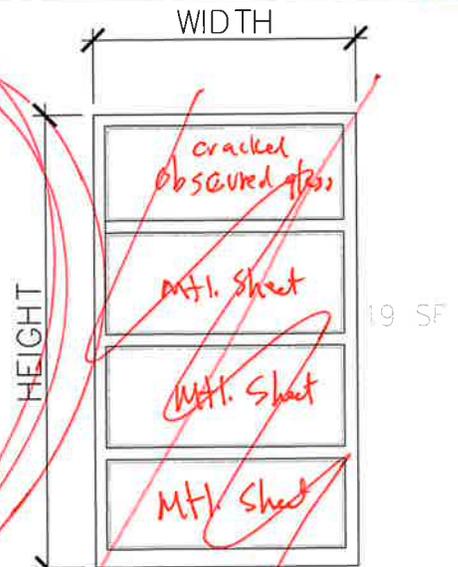
WINDOW NO. 531	EXPOSURE	TYPE U	FRAME MATERIAL	GLAZING MATERIAL	OVERALL CONDITION	EXTERIOR FINISH	INTERIOR FINISH	GLASS	FRAME	SASHES	HARDWARE	GLAZING MATERIAL	WEATHERSTRIPPING	SUPPORT MATERIAL	SILL	PERIMETER SEALANT
U-5312			METAL	S.G.	poor	poor		Bad	poor	N/A		Bad	Bad	Good	poor	Bad

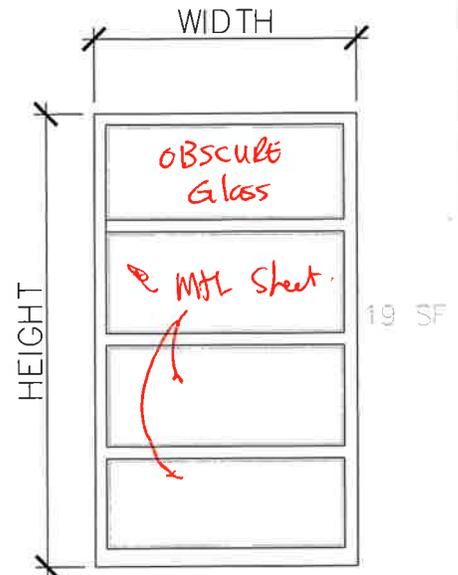
534		U																	
WINDOW NO.	EXPOSURE	TYPE	FRAME MATERIAL	GLAZING MATERIAL	OVERALL CONDITION	EXTERIOR FINISH	INTERIOR FINISH	GLASS	FRAME	SASHES	HARDWARE	GLAZING MATERIAL	WEATHERSTRIPPING	SUPPORT MATERIAL	SILL	PERIMETER SEALANT			
U-534-S			METAL	S.G.	Poor	Poor		Repl.	Poor	N/A		Repl.	Repl.	Stone	Poor	Repl.

① CLEAN/REPAINT

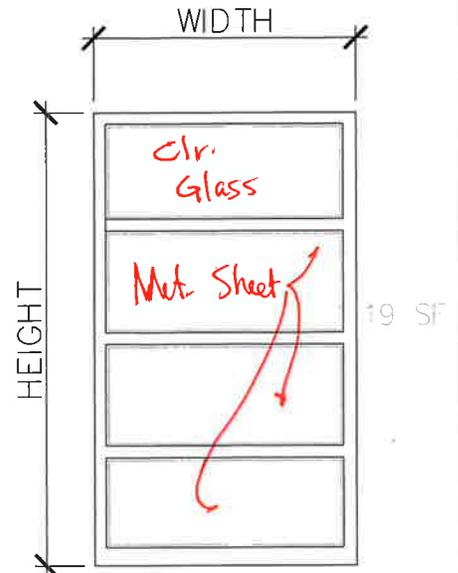
WINDOW				SPECIFIC CONDITION NOTES														
WINDOW NO.	EXPOSURE	TYPE		EXTERIOR FINISH	INTERIOR FINISH	GLASS	FRAME	SASHES	HARDWARE	GLAZING MATERIAL	WEATHERSTRIPPING	SUPPORT MATERIAL	SILL	PERIMETER SEALANT				
535		U																
U-535-S			METAL	S.G.	Poor	Poor	BAD	Poor	N/A	BAD	BAD	Good	Poor	BAD				
SCALE: 1/4" = 1'-0"				WINDOW SURVEY/WINDOW TYPES														
DATE:		JOB NO.: 2023.113		VAN ZANDT COUNTY COURTHOUSE										TYPE U				
				121 E. DALLAS STREET CANTON, TEXAS 75103										Sheet ___ of ___

① CLEAN/REPAINT

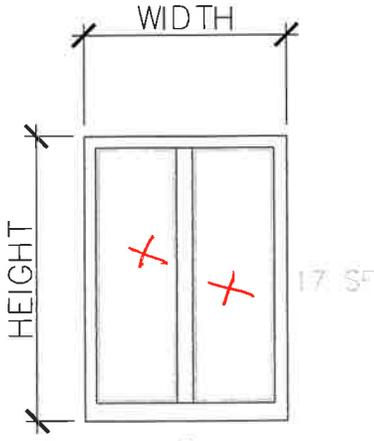
WINDOW		SPECIFIC CONDITION NOTES																				
WINDOW NO. 601																						
EAST	EXPOSURE																					
B	TYPE																					
B-601-E	FRAME MATERIAL																					
	GLAZING MATERIAL																					
	OVERALL CONDITION																					
	EXTERIOR FINISH																					
	INTERIOR FINISH																					
	GLASS																					
	FRAME																					
	SASHES																					
	HARDWARE																					
	GLAZING MATERIAL																					
	WEATHERSTRIPPING																					
	SUPPORT MATERIAL																					
	SILL																					
	PERIMETER SEALANT

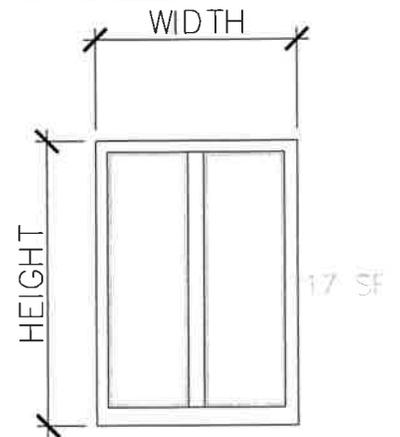
WINDOW		SPECIFIC CONDITION NOTES																				
WINDOW NO. 602	B	EXPOSURE	TYPE	FRAME MATERIAL	GLAZING MATERIAL	OVERALL CONDITION	EXTERIOR FINISH	INTERIOR FINISH	GLASS	FRAME	SASHES	HARDWARE	GLAZING MATERIAL	WEATHERSTRIPPING	SUPPORT MATERIAL	SILL	PERIMETER SEALANT					
B-602-W		<i>West</i>		METAL	S.G.	<i>Poor</i>	<i>Poor</i>		<i>Good</i>	<i>Poor</i>	<i>N/A</i>		<i>Bad</i>	<i>Bad</i>	<i>Good</i>	<i>Poor</i>	<i>Bad</i>					
SCALE: 1/4" = 1'-0"		WINDOW SURVEY/WINDOW TYPES												TYPE B								
DATE:		JOB NO.: 2023.113		VAN ZANDT COUNTY COURTHOUSE												Sheet ___ of ___						
KOMATSU ARCHITECTURE		121 E. DALLAS STREET CANTON, TEXAS 75103

① CLEAN/REPAINT

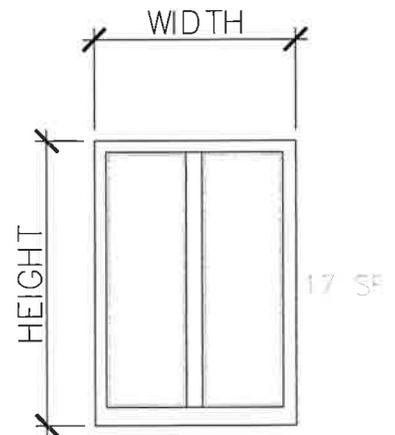
WINDOW		SPECIFIC CONDITION NOTES																				
WINDOW NO. 603	B	EXPOSURE	TYPE	FRAME MATERIAL	GLAZING MATERIAL	OVERALL CONDITION	EXTERIOR FINISH	INTERIOR FINISH	GLASS	FRAME	SASHES	HARDWARE	GLAZING MATERIAL	WEATHERSTRIPPING	SUPPORT MATERIAL	SILL	PERIMETER SEALANT					
B-603-S		<i>South</i>		METAL	S.G.	<i>Poor</i>	<i>Poor</i>		<i>Good</i>	<i>FAIR</i>	<i>N/A</i>		<i>Replace</i>	<i>Replace</i>	<i>Good</i>	<i>Poor</i>	<i>Severe rusting</i>	<i>Poor</i>				
SCALE: 1/4" = 1'-0"		WINDOW SURVEY/WINDOW TYPES										TYPE B										
DATE:	JOB NO.: 2023.113	VAN ZANDT COUNTY COURTHOUSE																				
KOMATSU ARCHITECTURE		121 E. DALLAS STREET CANTON, TEXAS 75103										Sheet ___ of ___

① CLEAN/REPAINT
